Nauset Environmental Services

Re: bulk sample of suspect ACM

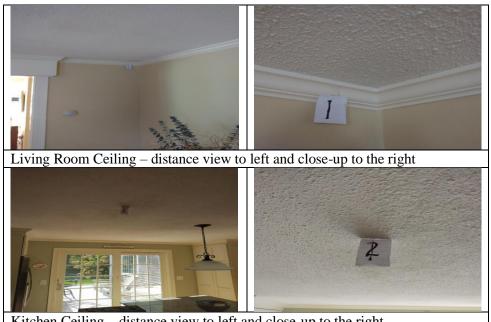
Kitchen Ceiling – distance view to left and close-up to the right

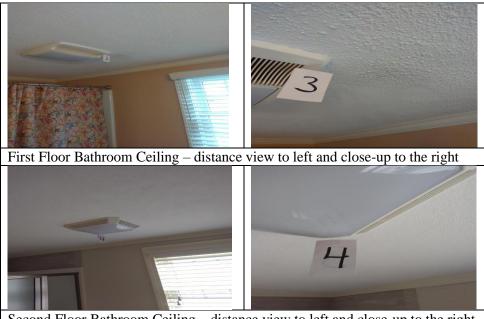
Second Floor Bathroom Ceiling – distance view to left and close-up to the right
