# Nauset Environmental Services

Re: Mold/Moisture Inspection

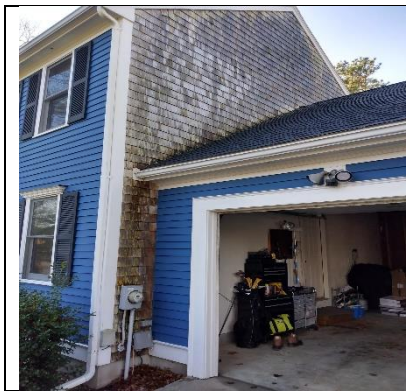
Note how wet the cedar shingles on the north-facing gable end, particularly the section immediately opposite the attic.

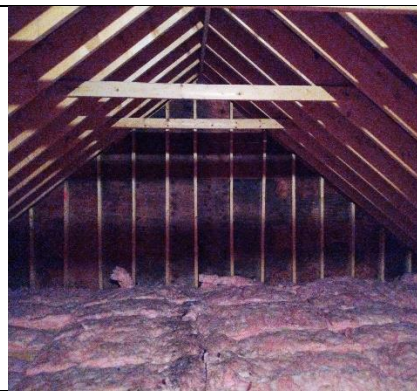
Notice significant staining on sheathing on north-facing gable wall in attic which, when tested with the Tramex moisture meter (MM) showed saturated conditions.

As noted in the captioned photo above, our inspection of the attic revealed that the north-facing sheathing on the northern gable wall is stained and saturated.

1. Exhaust ventilation should be installed in both bathrooms so that steamy air from baths and showers is captured and exhausted out of the house.
2. The attic sheathing in the north-facing gable wall is saturated. This is evidence the attic ventilation needs to be improved. A well-ventilated attic should have equally effective upper and lower venting. There appears to be a ridge vent (upper venting) running the length of the house. It is possible the "hockey puck" type soffit vents (lower venting) are inadequate. We recommend you retain the services of a competent energy auditor to evaluate this. The Commonwealth's Mass Save program ([masssave.com](http://masssave.com)) can provide a referral. Mass Save energy audits are free and the improvements recommended by the auditor are often heavily subsidized by the Mass Save program.

3. Water vapor may be infiltrating the attic around the thin plywood barrier separating the attic from the occupied portion of the home. Installation of a thermal dome would probably remedy this. Again, this is a service the Mass Save energy auditor can often provide.

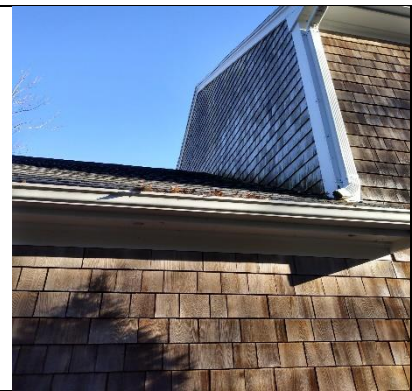
Note debris in the gutter. Also note the small, "hockey puck" style soffit vents that extend around the house which may contribute to inadequate attic ventilation.

6. Several gutters showed evidence of excessive debris. They should be cleaned out to prevent ice dams.
7. Scented candles should be used sparingly and always ventilate the space after their use.
8. We do not believe the air sampling data are indicative of a situation requiring professional mold remediation service. A thorough house cleaning with a vacuum cleaner equipped with HEPA filtration should suffice for now. The vacuum cleaner *must* have HEPA filtration. Use the vac's hand attachment to clean dust off the windowsills and edges. The small patches of VMG we observed can be cleaned with the HEPA vac hand attachment. It would be prudent for anyone using a vacuum cleaner to wear appropriate respiratory protection; an N95 mask at a minimum.

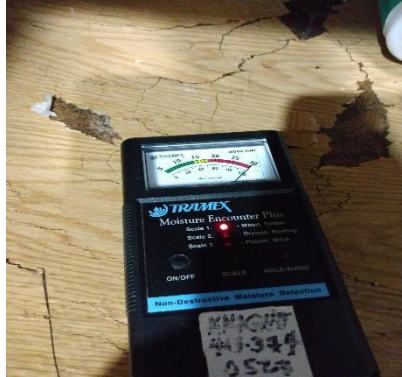
Using a Tramex moisture meter (MM), we detected elevated moisture levels in the particleboard shelf directly below the kitchen sink and also all along the cove molding on the L-shape portion of the kitchen counter. The particleboard below the sink is sagging quite severely which indicates there have been one or more significant water releases there.

<p>The particleboard shelf under the kitchen sink has collapsed from excessive moisture and the Tramex moisture meter (MM) revealed saturated conditions.</p>	<p>The particleboard on the L portion of the kitchen cabinetry shows saturated conditions when tested with the MM.</p>	<p>VMG on the underside of the kitchen cabinetry cove molding.</p>

4. There appears to be an active leak in the kitchen under the sink and/or dishwasher. The cabinetry there needs to be removed so that a plumber can inspect the area thoroughly and diagnose and remedy the problem(s).

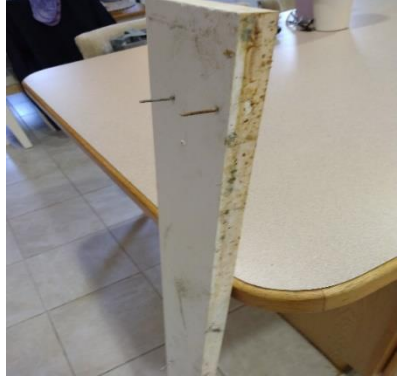
The tenants shared a recent photo they had taken in the basement documenting a recent release of water from the first floor which appears to line up with the kitchen cabinetry. There is a small bit of visible mold growth (VMG) on the back side of the wooden kick plate the tenant removed from the L portion of the kitchen cabinetry.

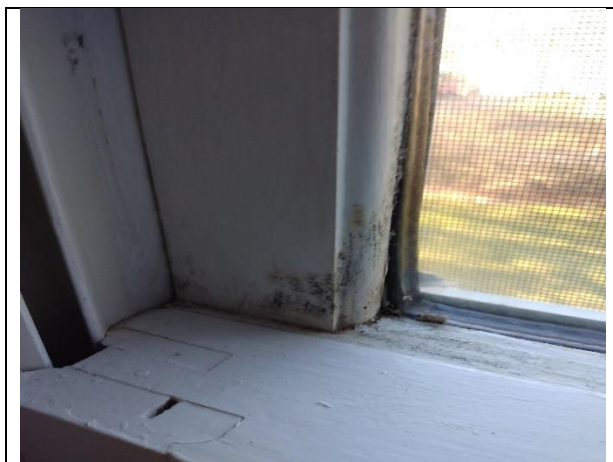
There was also some VMG on one of the wooden windows in the master bedroom which the tenants attribute to excessive condensation on the window glass. Any such instances of excessive condensation on the home's windows is likely due in large part to the absence of bath fans to capture and exhaust shower steam out of the house. There were also several scented candles burning in the home during our visit. According to [bard.google.com](http://bard.google.com): *"During the burning process, candles release water vapor as a byproduct of combustion. This moisture adds to the overall humidity level."* Also *"When burned, paraffin wax can release chemicals like benzene and toluene, which are known carcinogens."*

VMG on a wooden window in the master bedroom.
