# Nauset Environmental Services, Inc.

NES Job #3-1392  
Report No. NES/IAQ-13/1471

Re: Mold/moisture inspection + Scope of Work  
for 109 Pinewood Road (Truro)

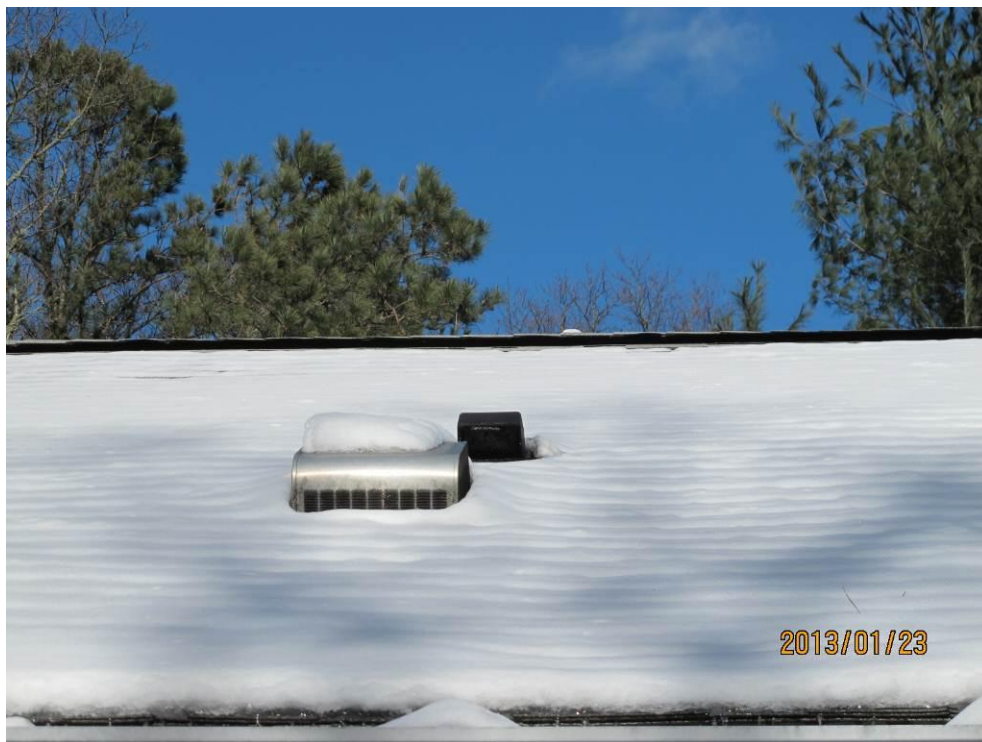
- The rear roof was snow-covered with obvious vents for the bathroom shower, the clothes dryer and the stove (see photos). [See further discussion and photos from inside the attic below.]

Vents from the bathroom area – large = shower & small = dryer

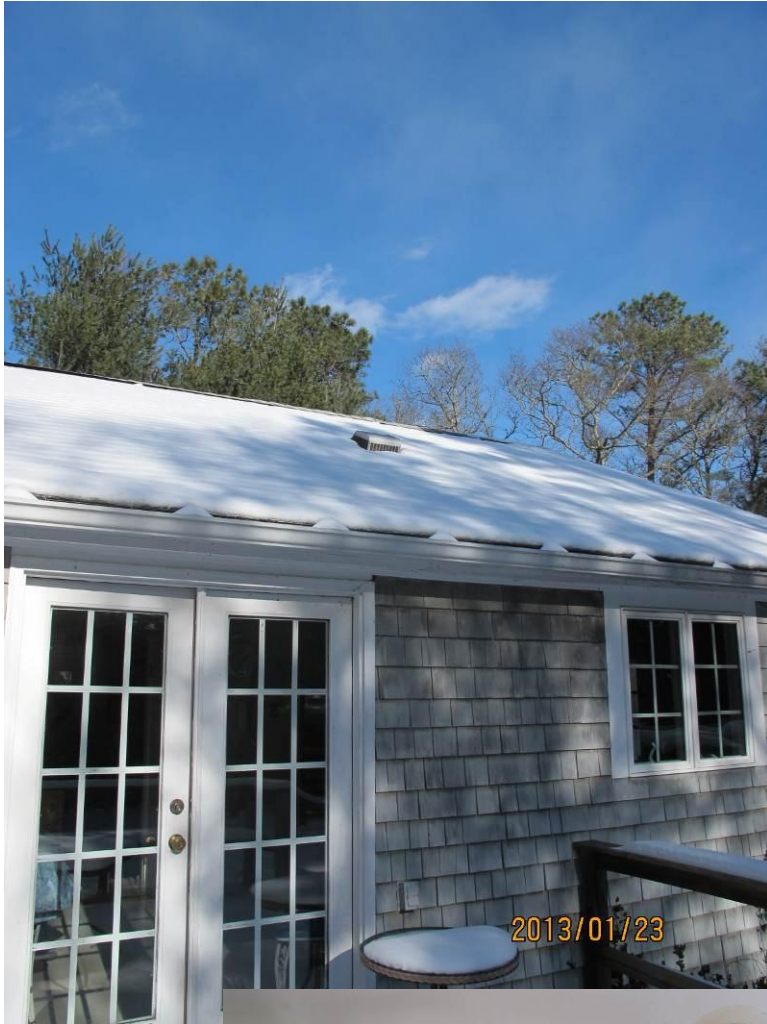
Kitchen vent

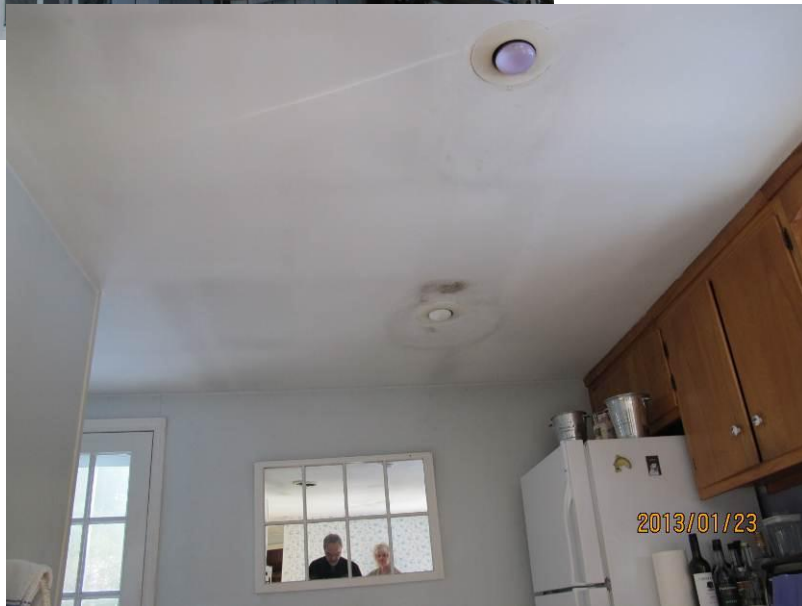
- There were linear hazy areas on the kitchen ceiling and isolated, obvious areas of VMG near recessed light fixtures (see photos).

Viewing to east (left) side of kitchen where there is localized VMG near light fixture and linear haze/ghosting

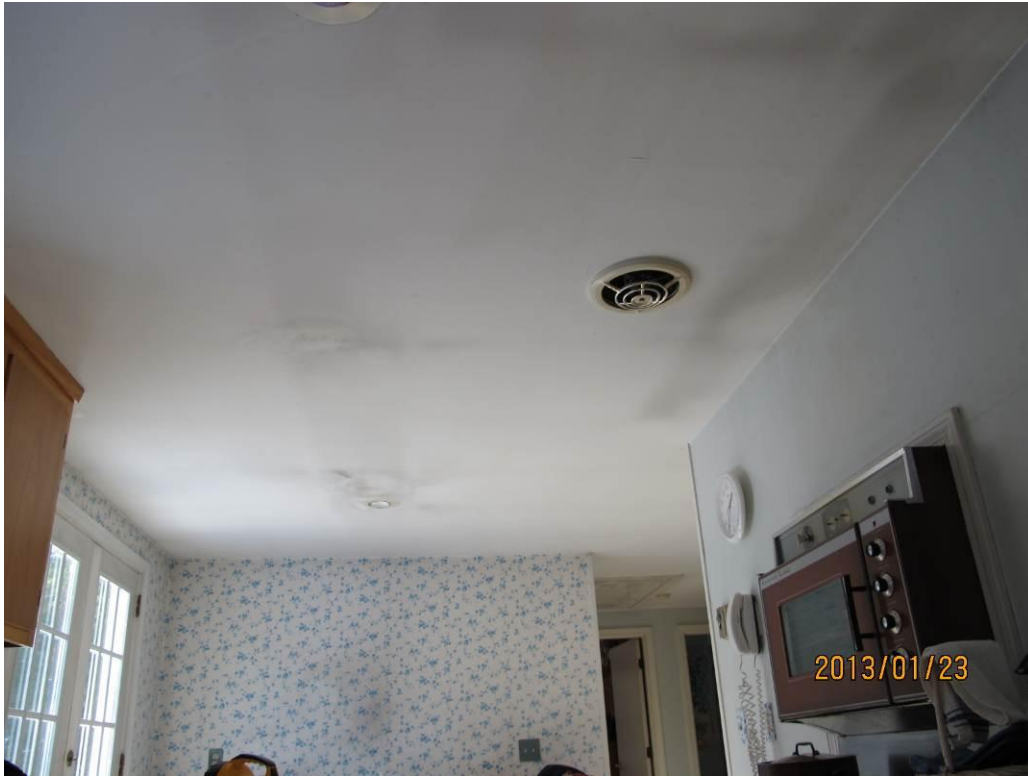
Viewing to west (right) side of kitchen where there is localized VMG near light fixture and linear haze/ghosting

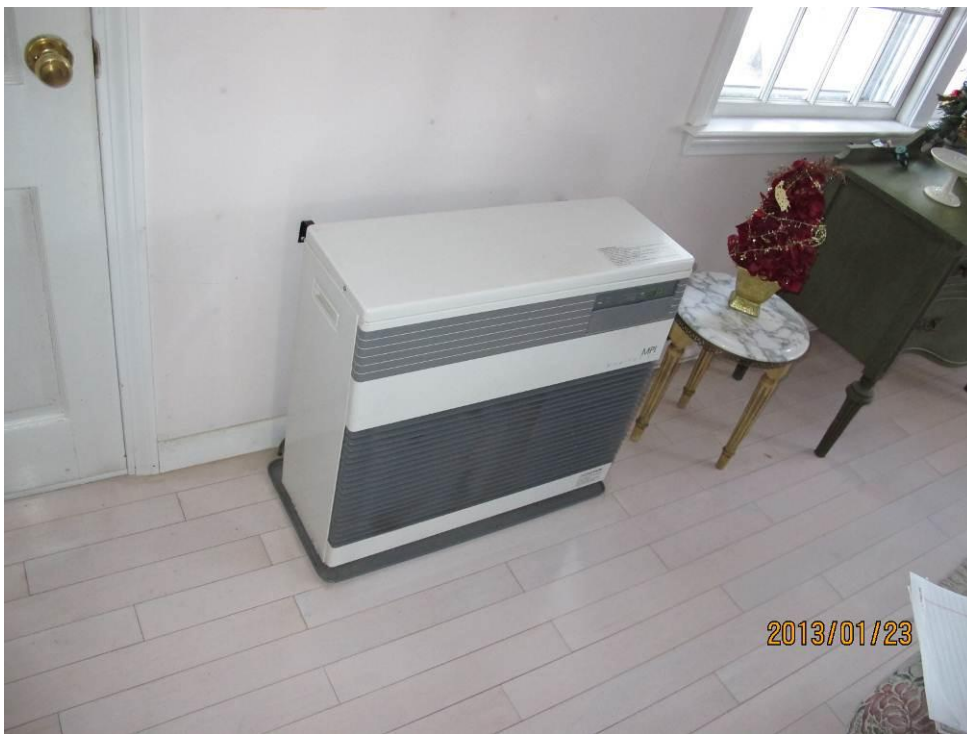
On the first floor that was also widespread “ghosting” or shadowing discoloration opined to be due to soot deposits from the kerosene-fired wall-mounted heating system that have settled on cooler surfaces in the house.

Monitor wall-mounted heater in living room

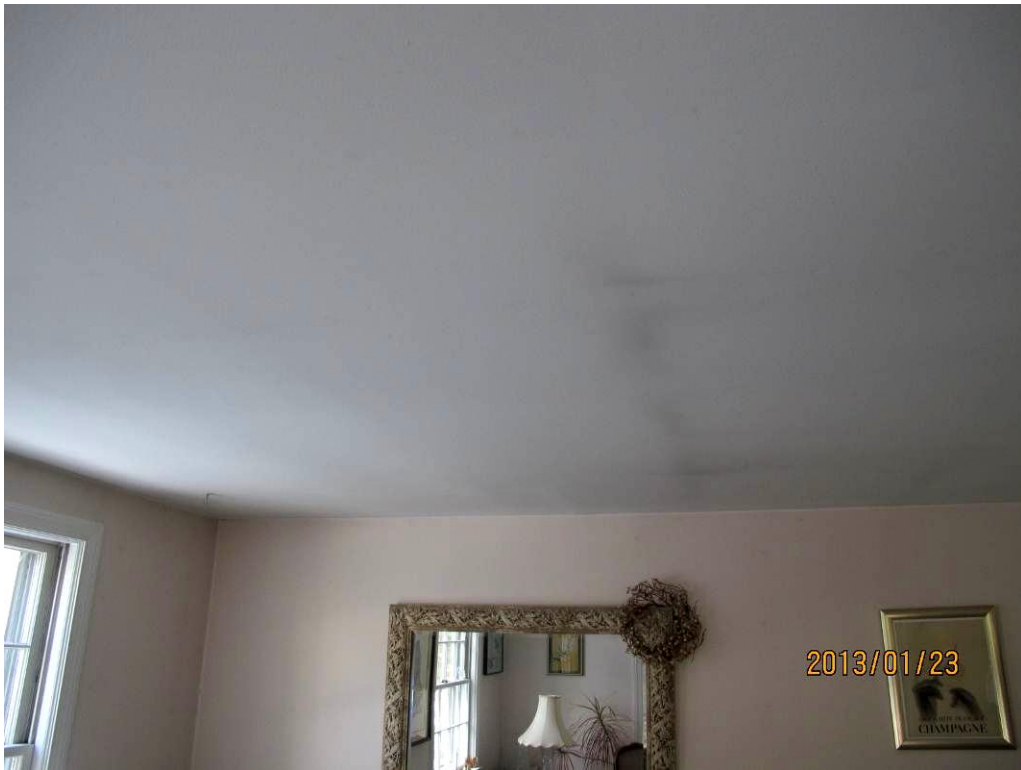
- There was a linear pattern of hazy discoloration on the ceiling and walls as well as discoloration on the walls where drywall nails were located (see photos). This pattern is identical to that for soot deposition on cooler, less insulated surfaces. Since Ms. Walsh reports NO burning of jar candles and rare use of stick candles during more “formal” dinners in the dining room, the most likely source of the observed hazing/ghosting is soot from the Monitor heater. The ceiling-wall corners and wall-wall corners also exhibit darker hazing/ghosting (see photos) coincident with areas of structural wood and no insulation. [NOTE: Any cooler surface, even small areas like drywall nail head, will have will have less thermal turbulence allowing more particles to settle compared to warmer areas where there is adequate insulation. The soot settling builds up over time until it is visible, as is the case in this house.]

Hazing/ghosting on living room ceiling (see attic discussion & photos as well)

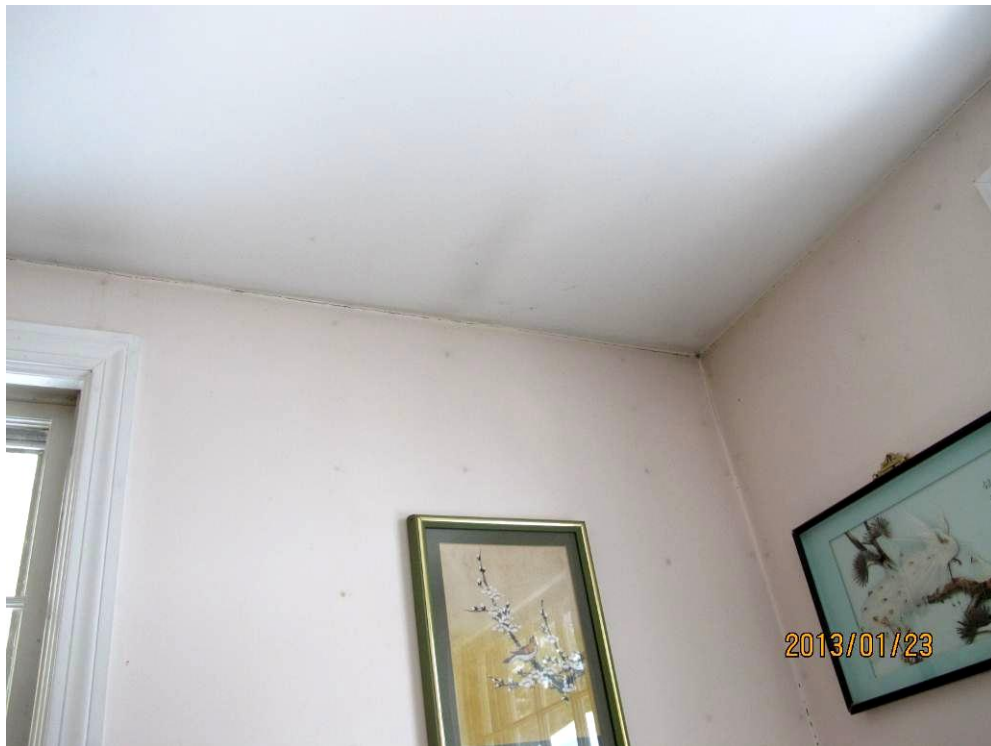
Hazing/ghosting along front wall and right corner of living room

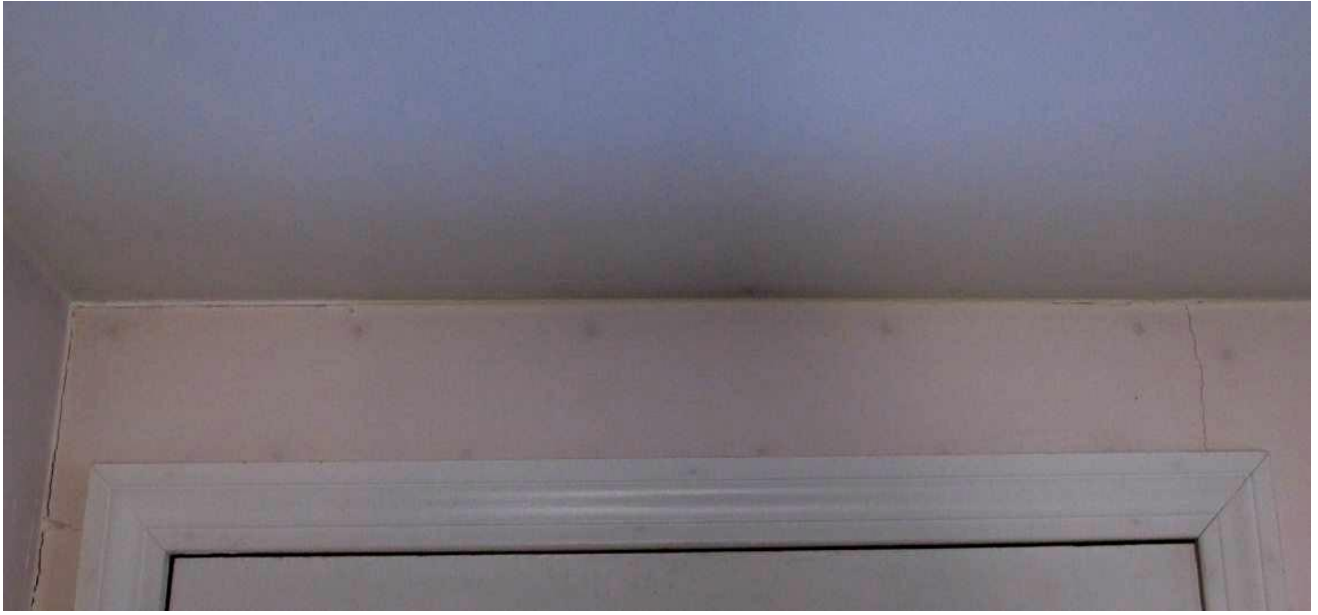
Drywall nails evident over front door

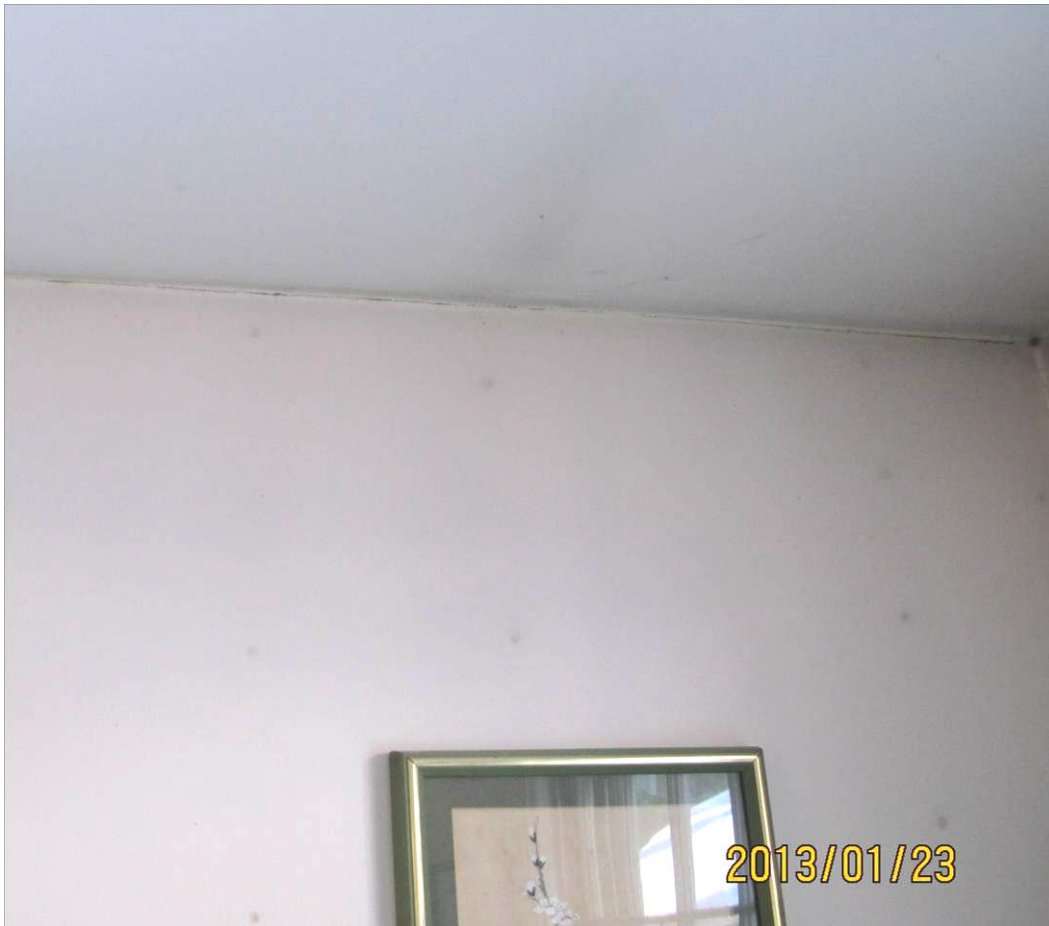
Drywall nails and ceiling corners showing hazing/ghosting on front wall

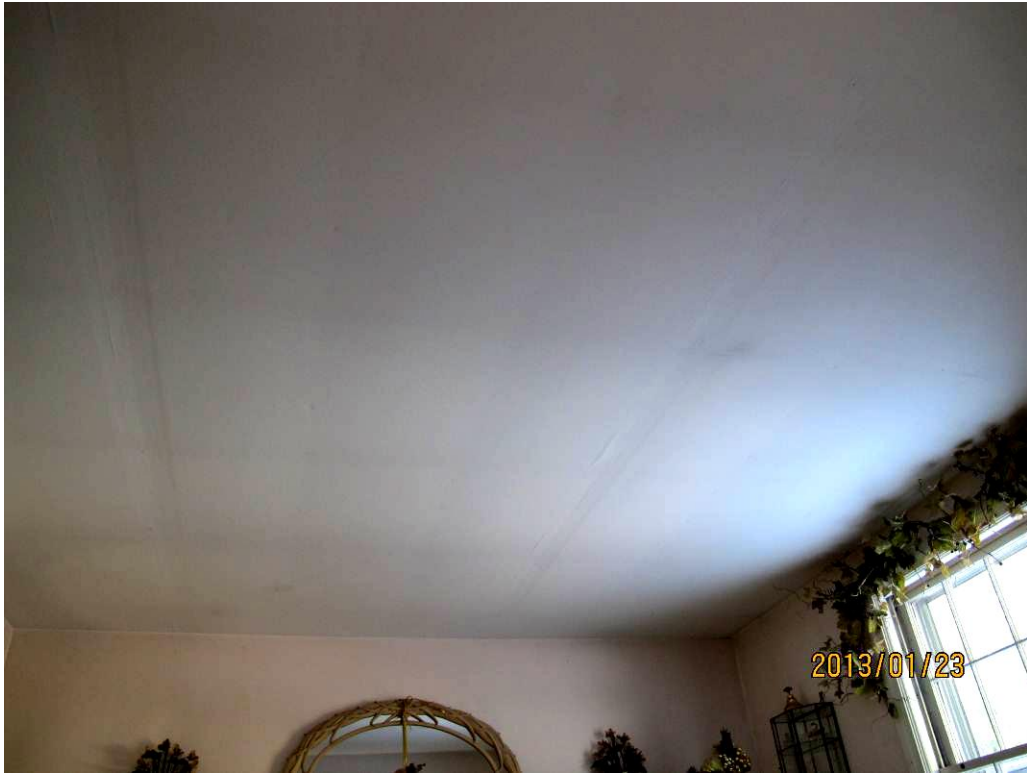
- There was also a linear pattern of hazy discoloration on the ceiling of this room, similar to a tick-tack-toe grid (see photo). This pattern also appears to be from soot-related particles.

Grid pattern of hazing/ghosting in dining room

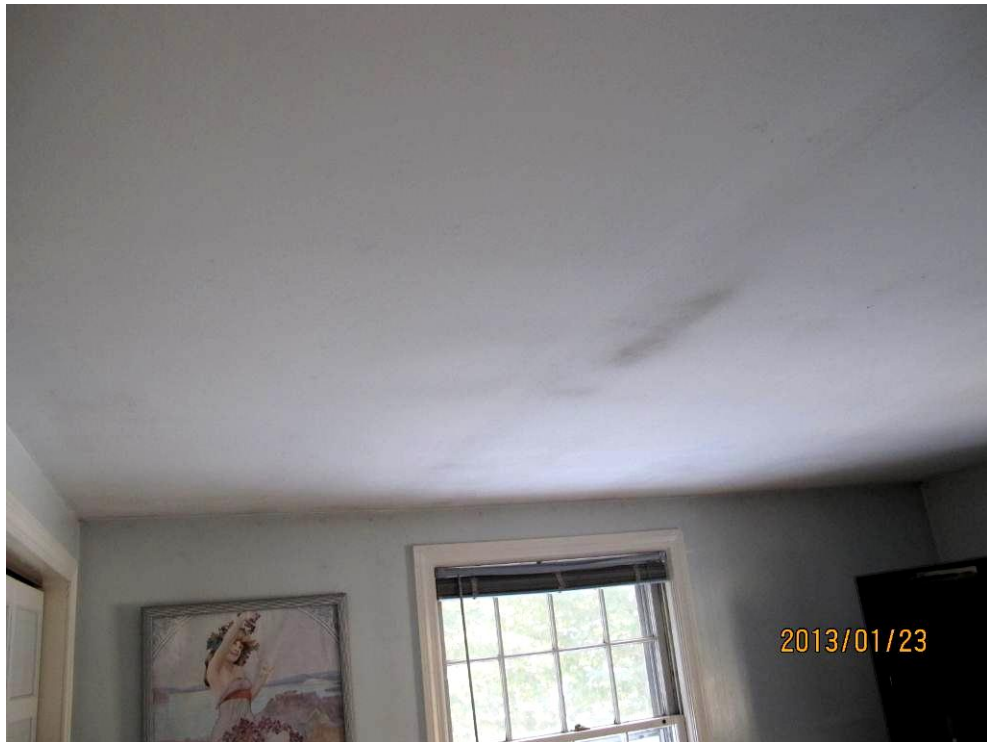
- There was also a linear pattern of hazy discoloration on the ceiling of this room (see photo). This pattern also appears to be from soot-related particles.

Hazing/ghosting in master bedroom

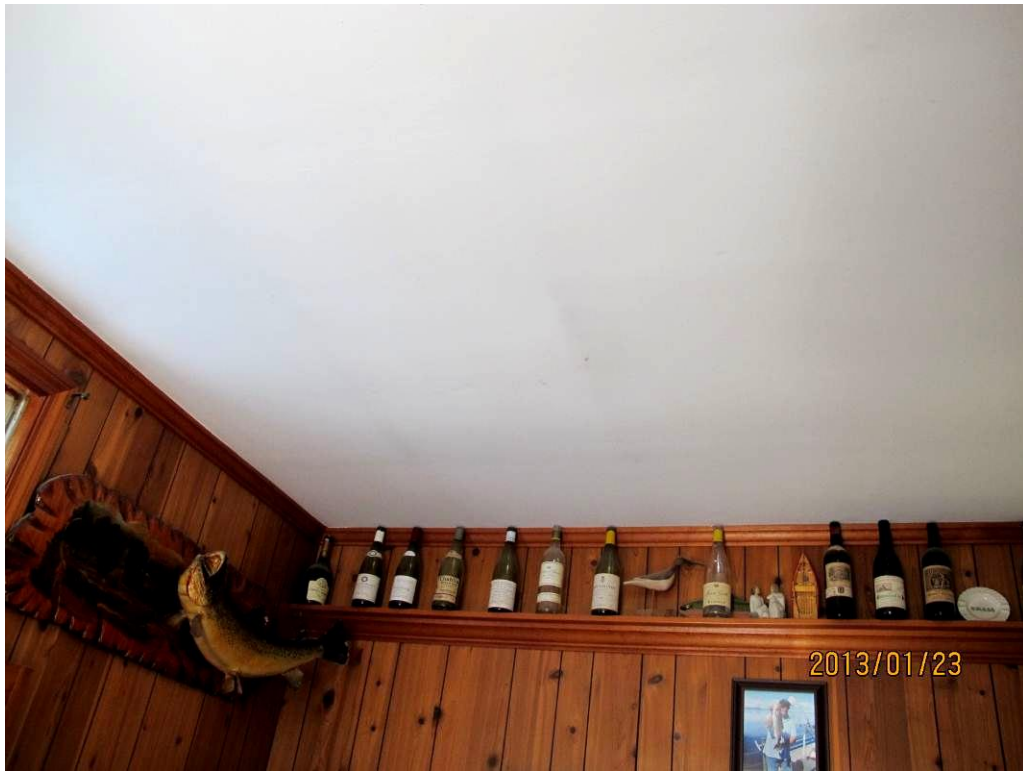
- There was also a linear pattern of hazy discoloration on the ceiling of this room, but lighter than the living room and dining rooms that were closer to the Monitor heater (see photo). This also appears to be from soot-related particles.

Hazing/ghosting in right rear paneled room

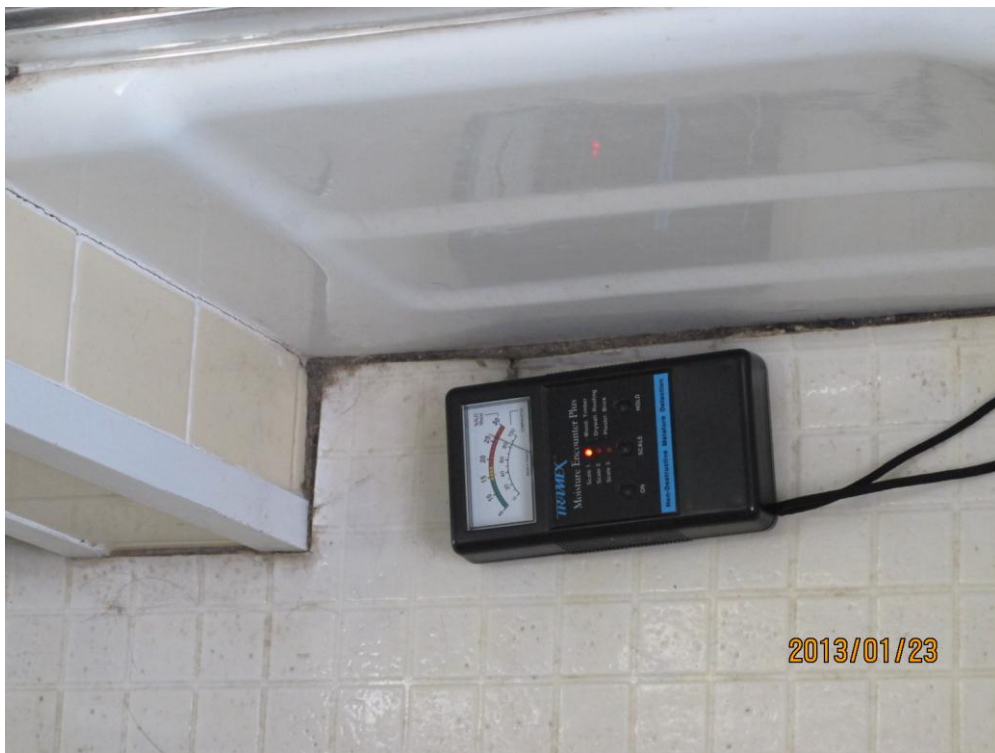
- There was isolated, limited VMG around the shower exhaust/light fixture and the light fixture over the sink (see photos).
- The sheet flooring was peeling up next to the tub/shower. Moisture meter readings indicated acceptable dry conditions around the floor and adjacent to the toilet pedestal but elevated moisture near the foot of the tub where it read 28% moisture in wood (MW) (see photo), probably associated with water seeping around the door seal. All other readings were near 15% MW.
- While there is an exhaust fan over the shower, its timer switch does not appear to function to control the exhaust automatically.

Excess moisture (28% MW) in bathroom floor near foot of tub/shower

The excess moisture in the bathroom can be corrected by installing a new exhaust fan with more power that is controlled by a functional timer switch.

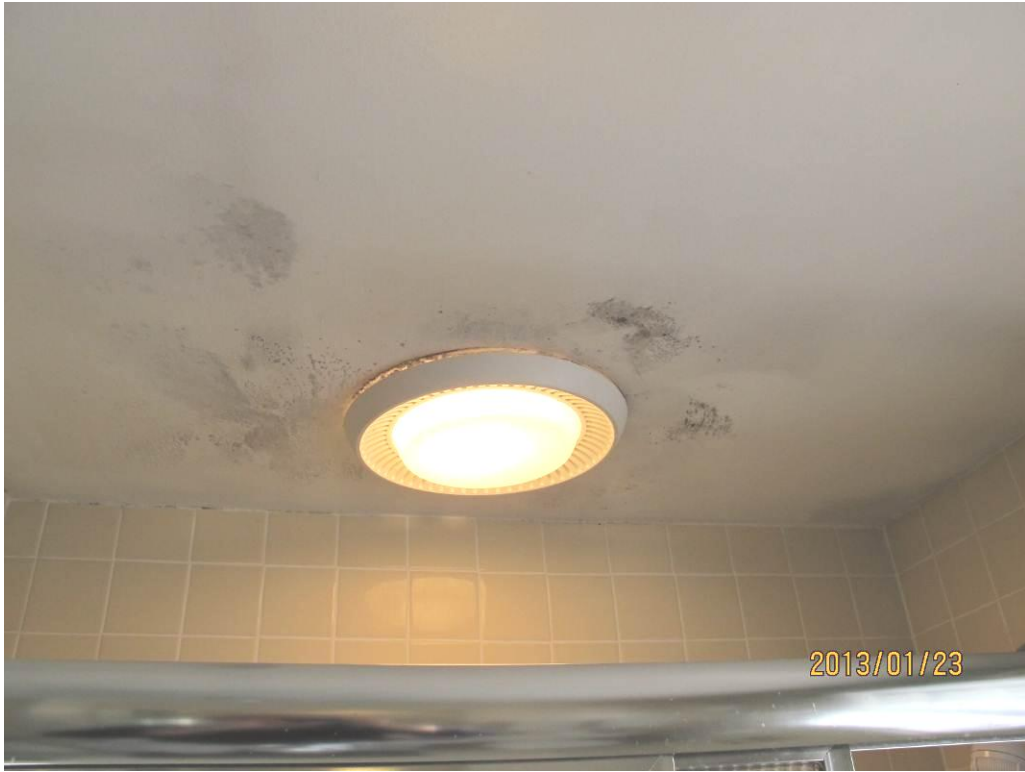
VMG around shower exhaust fan

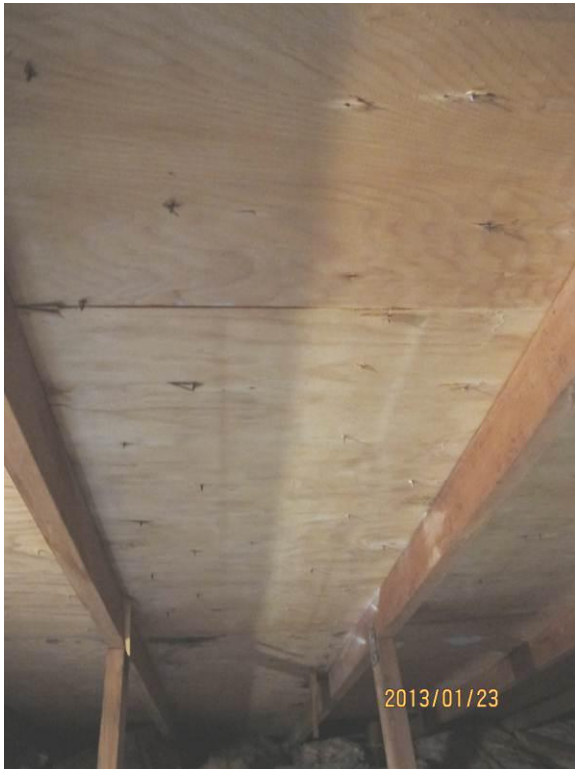
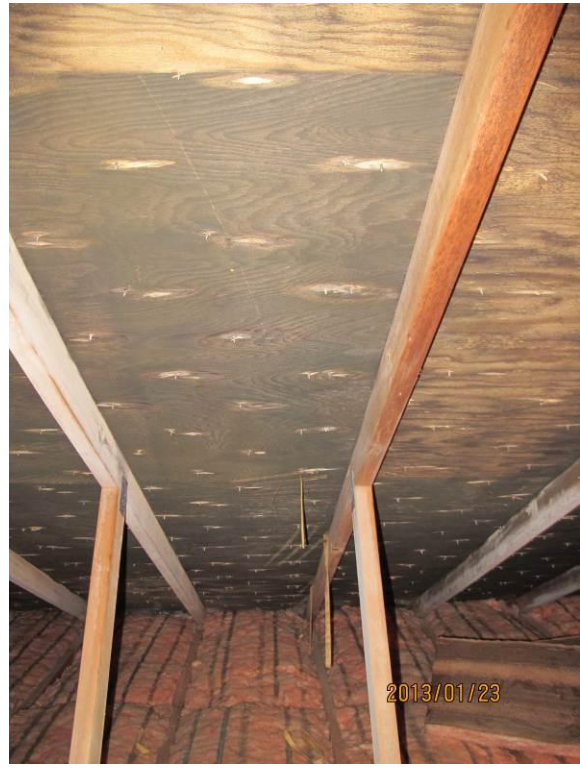
- There was obvious dark discoloration in the sheathing on the north side of the attic but little discoloration in the south side sheathing that has been in place since the roof was replaced in 1995 (see photos). The dark discoloration on the north side DID NOT RUB OFF under finger pressure, indicating it was in the grain of the plywood and not readily released to the air where spores might be inhaled, essential for exposure resulting in allergic reactions. Since the ‘new’ south side sheathing is not impacted while some of the south sheathing has discoloration, that pattern on select sheets indicates older mold growth, probably related to the replaced, deteriorated roofing that dampened the sheathing by oozing water, NOT recent conditions in the last 17 years.

Clear 17-year old sheathing on south (rear) sheathing as opposed to darkened north side sheathing

Hence the north side discoloration is primarily cosmetic and does not call for health-related removal. [IF there is a desire to remove the discoloration at some point, it will be more cost effective to replace all the sheathing the next time the roofing is replaced.]

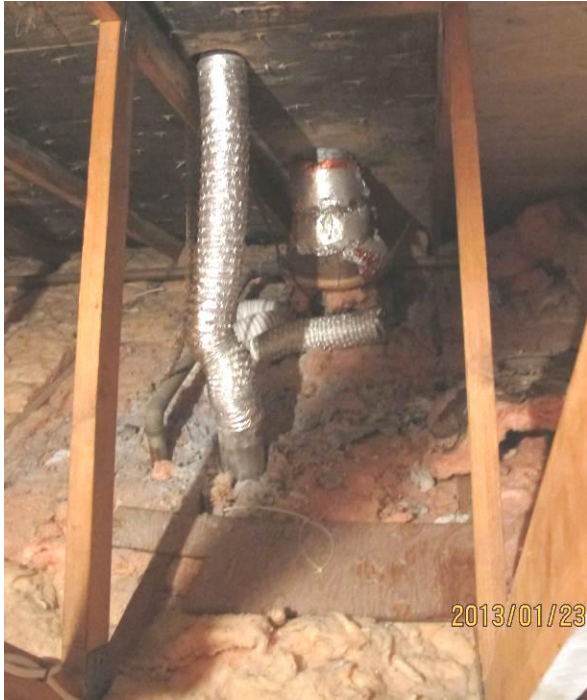
- The vents from the shower, dryer and kitchen were all attached to their respective exterior structures (see photos).
- The insulation was pulled back from the installation of each on the recessed lights in the kitchen, near the bathroom exhaust fan as well as the sink light fixture (see photos). This situation would allow those ceilings to cool considerably during winter months leading to dew point condensation in the living space where there are moisture sources from human respiration, cooking and showers. Hence the VMG observed on the first floor is readily associated with these areas of failed insulation, not any pervasive problem with the house.

Dryer and shower vents attached properly but without tie-wrap on drying vert.

- BE SURE THAT ANY GAPS AROUND CEILING FIXTURES ARE SEALED to reduce air movement into the attic, possible using expanding foam, tape, or caulk.
- Ensure that exhaust hoses from appliances to roof vents are tightly secured with proper sized tie-wrap cables or hose clamps to prevent exhausting moist air into the attic.

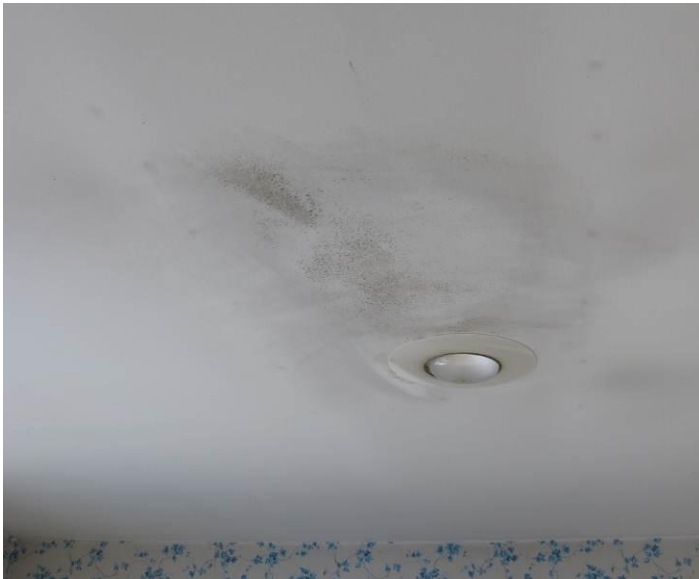
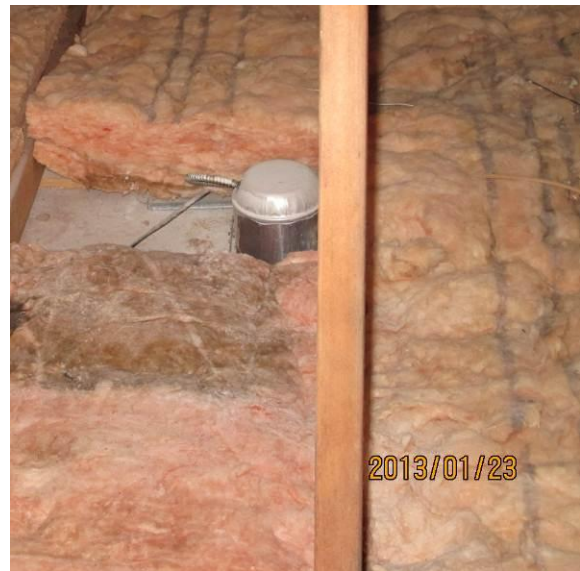
1. There are areas in the attic near ceiling penetrations for an exhaust fan and several recessed light fixtures where the insulation was initially pulled back and never returned to its proper functioning position. The resulting spot defects in insulating the ceiling has led to winter “cold spots” that have brought the local ceiling surface temperatures below the dew point temperature of the occupied space where occupants, cooking and showering are adding moisture to the air. The resulting limited areas of condensation have stimulated the digestive enzymes in mold spores that are present sufficient to digest organic matter present and develop localized colonies perceived as VMG, Condition 3 contamination.

Kitchen ceiling VMG under fixture where insulation had not been replaced

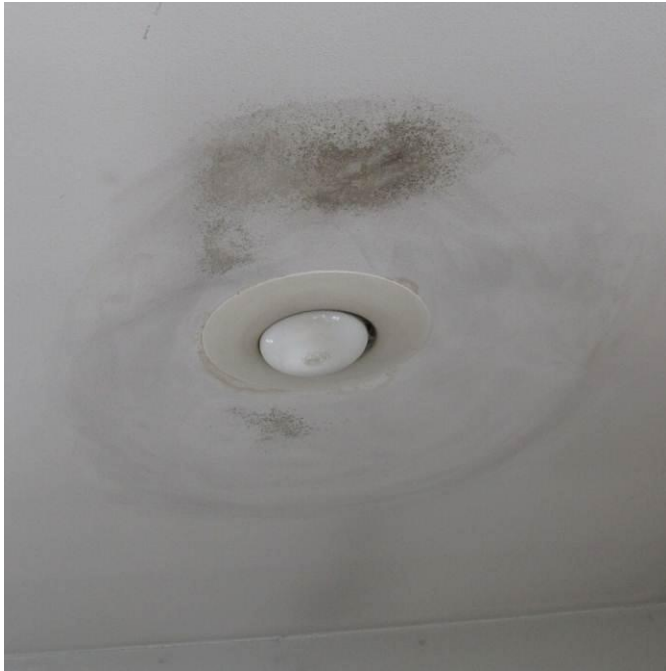
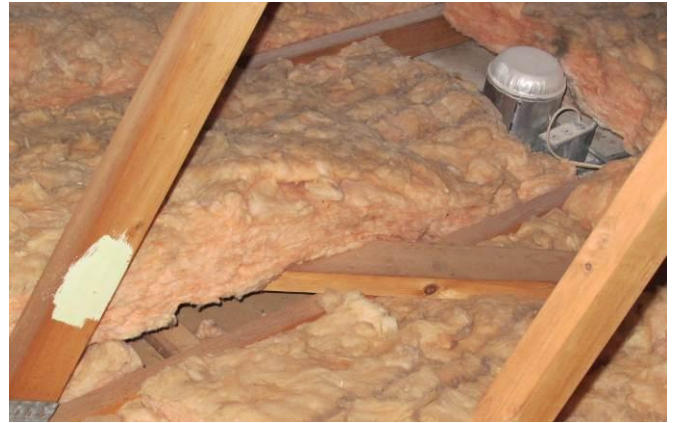
Kitchen ceiling VMG under fixture where insulation had not been replaced [Note are in foreground where insulation had been lifted up over a piece of wood, reducing the insulation of the ceiling and leading to an area of hazing/ghosting

Since there are no conditions of excess moisture associated with leaks or water releases, the localized excess condensation on ceiling surfaces needs to be reduced by correcting the flawed insulation installation in the attic. In addition:

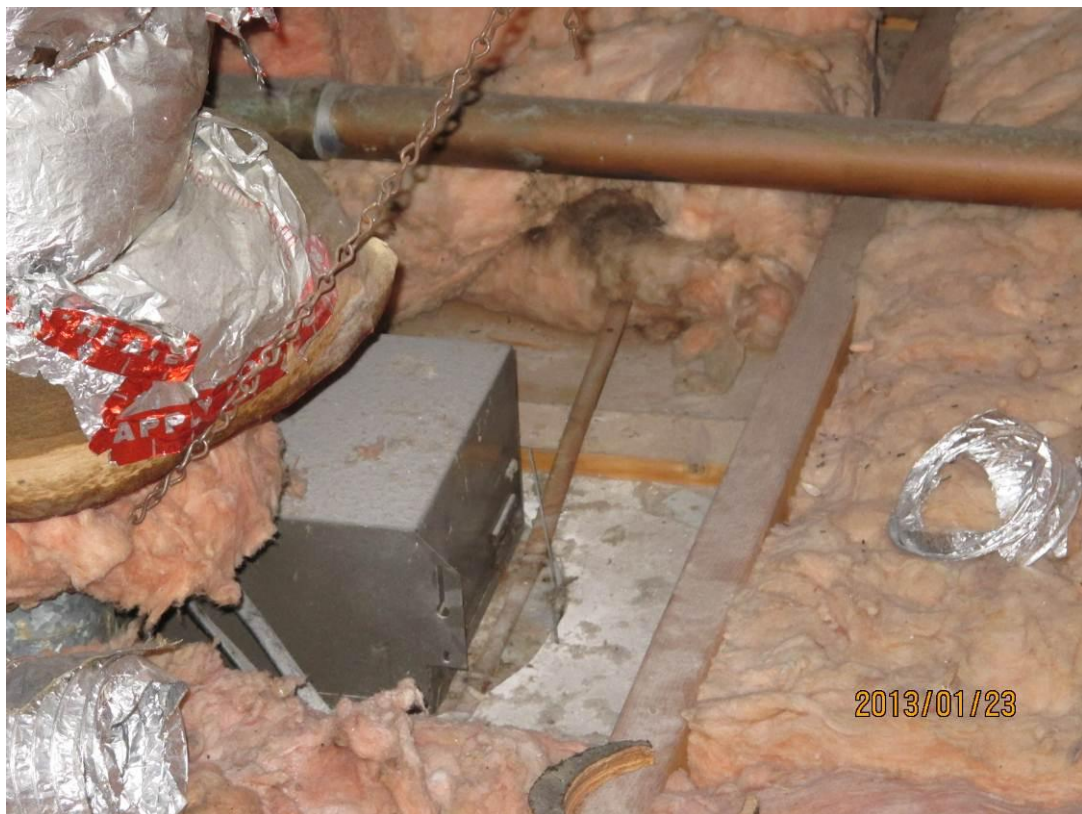
Area near bathroom exhaust fan showing large uninsulated surface (compare to earlier view of VMG)

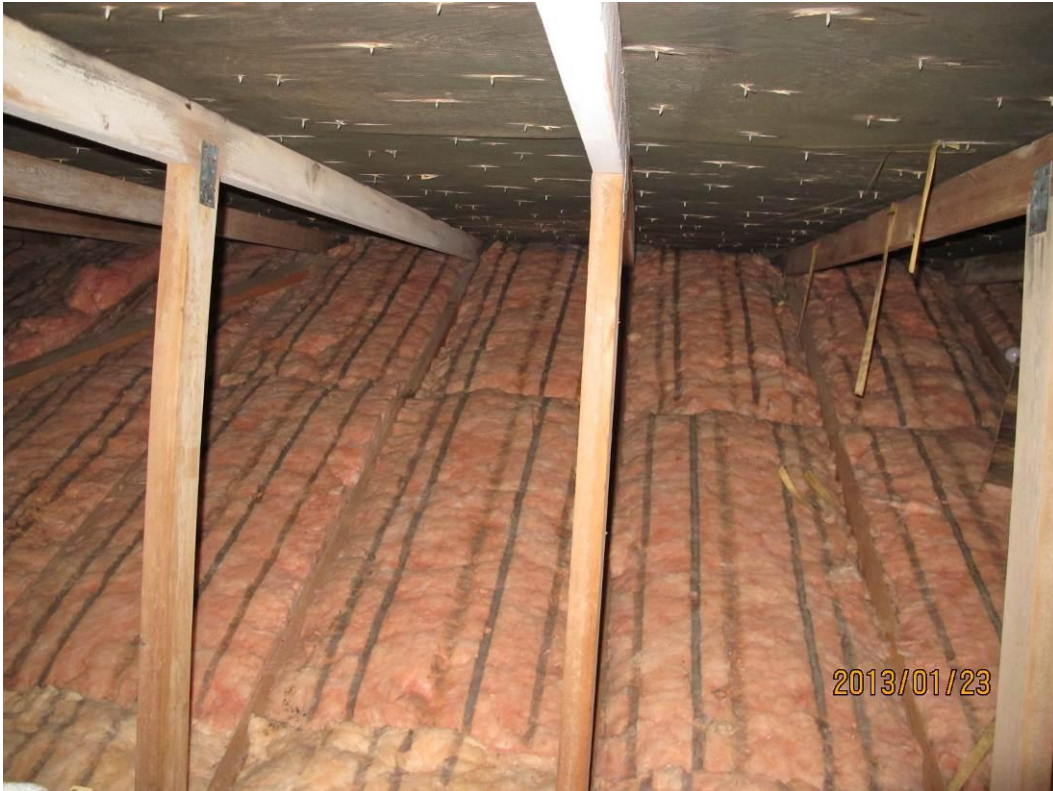
Insulation on north side of attic where there is an evident dip in the insulation where batts are not fully butted together, leading to cooler, linear surfaces in the ceiling below

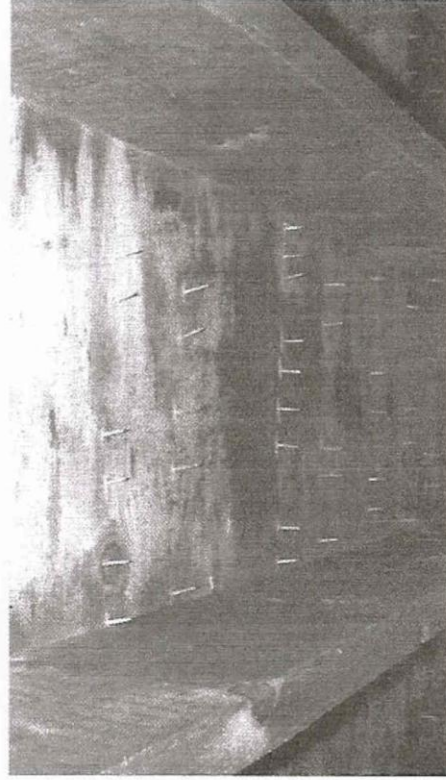
Black mildew on attic sheathing. The nails (protruding through the sheathing between the two rafters) are what hold the roof shingles onto the sheathing. This north-facing slope of a gable roof is covered with black microfungi (not *Stachybotrys* mold). The black growth gets denser toward the overhang (at the bottom of the picture) where it is colder. The white ovals at the nail penetrations indicate a lack of mold growth; the zinc that leaches from the galvanized nails into the wood is toxic to mold.

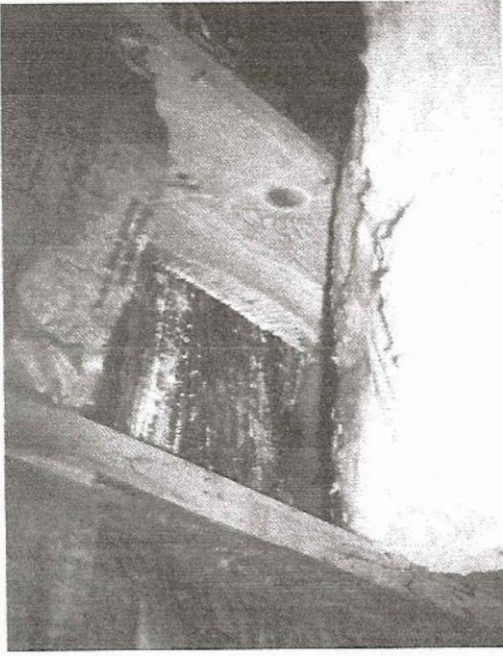
Rotted sheathing in a flat roof. The dark plywood sheathing between the lighter-colored rafters has been damaged by wood-decaying fungi. Water poured out of the fiberglass as the insulation was lowered, and the white semicircular threadlike pattern above the knot in the rafter is probably the mycelia of macrofungi that were starting to destroy the wood structure because of the saturated conditions.
