Nauset Environmental Services, Inc.

NES Job # 3-888
Report No. NES/IAQ-09/1033

Re: Mold/moisture inspection
for 69 Ridgewood South (W. Chatham)

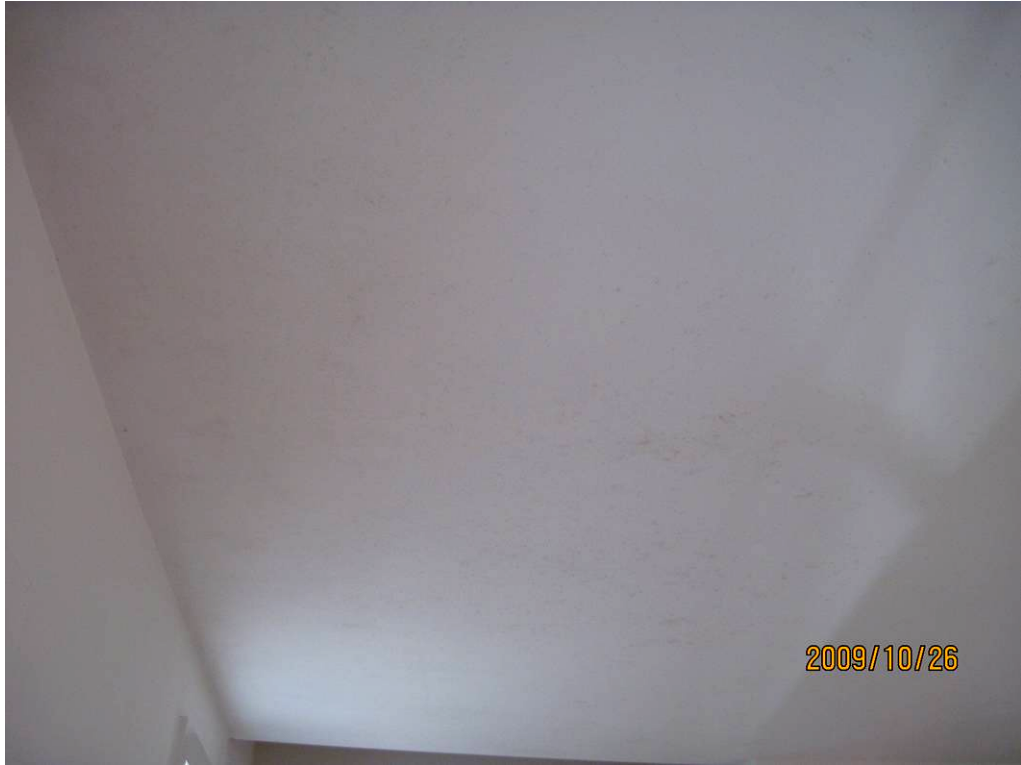
- There was condensation mold growth (CMG) on the front ceiling in the living room

Blotchy CMG on living room ceiling

- Use a HEPA-filtered vacuum to clean the affected surfaces since the HEPA (high efficiency particulate air) filter retains small particles like mold spores and reduces their dispersal
- Once a surface is cleaned it can be wiped with an appropriate moldicide OR painted with a mold-resistant paint. Paints from Fiberlock, Drilok and Zinsser can be found with multi-year warranties resist mold growth.

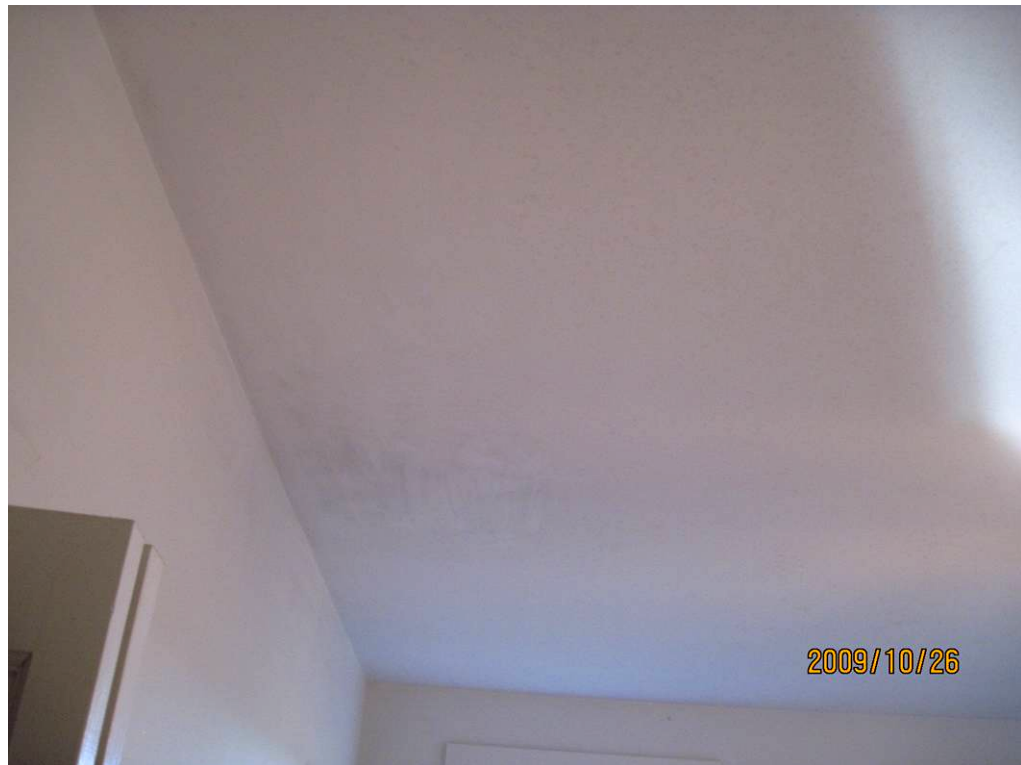
Blotchy CMG on left rear bedroom ceiling

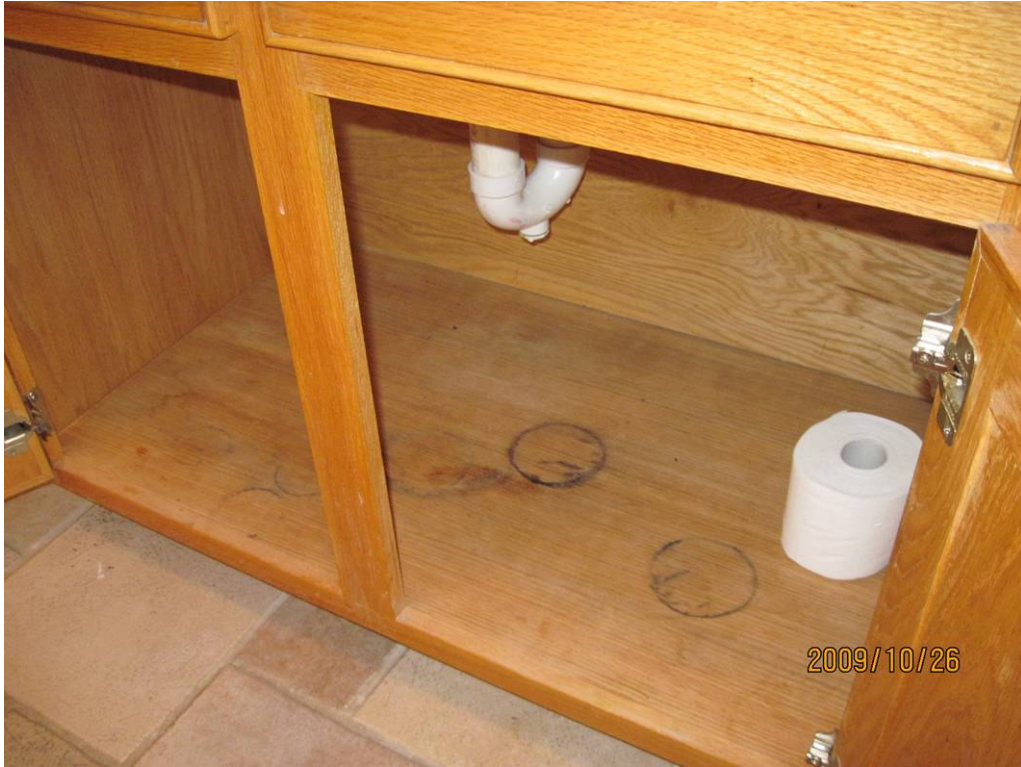
Rust stains under bathroom sink but no mold growth

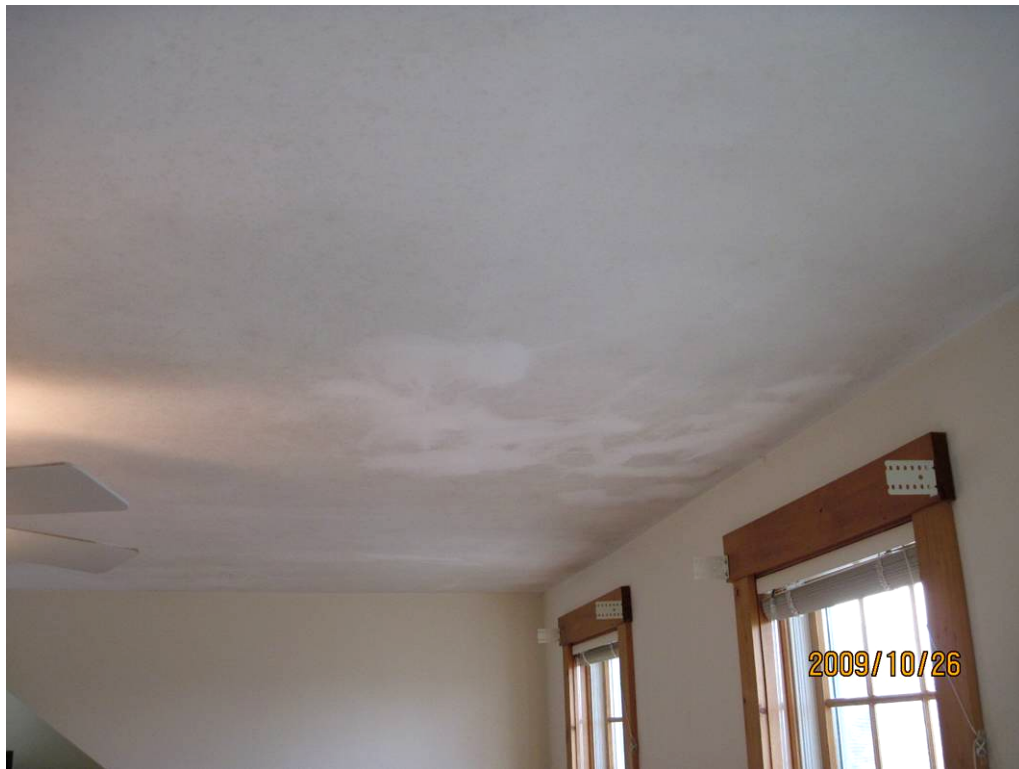
CMG in second floor bedroom where an attempt was made to wipe it off

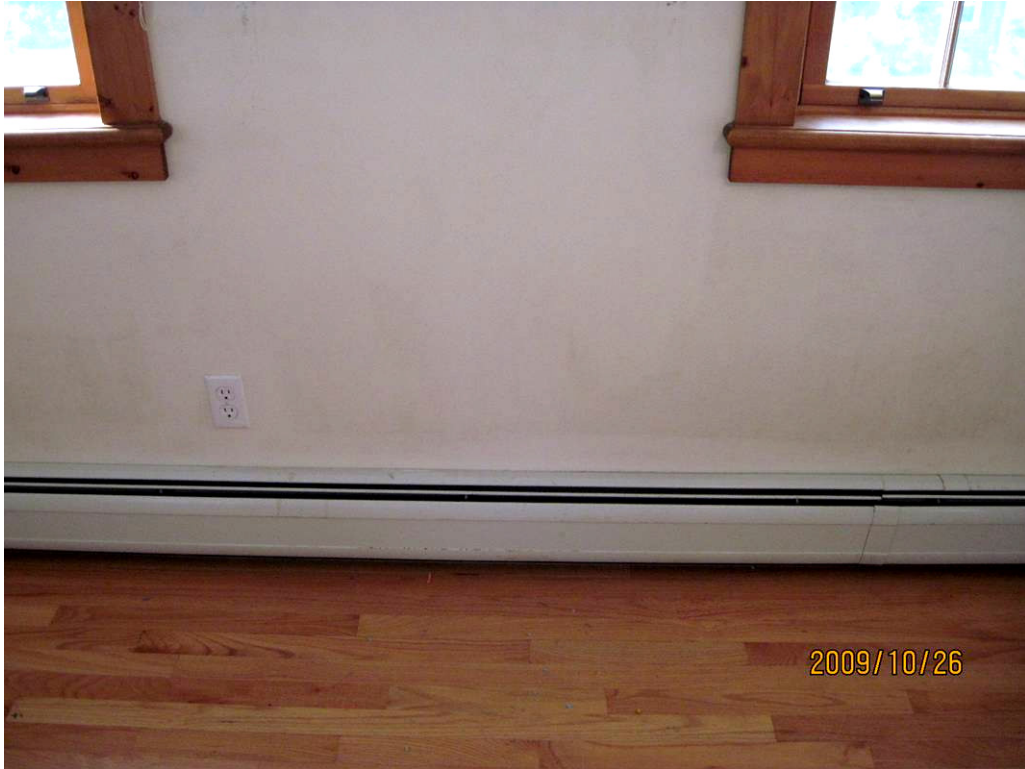
CMG on front wall of second floor bedroom

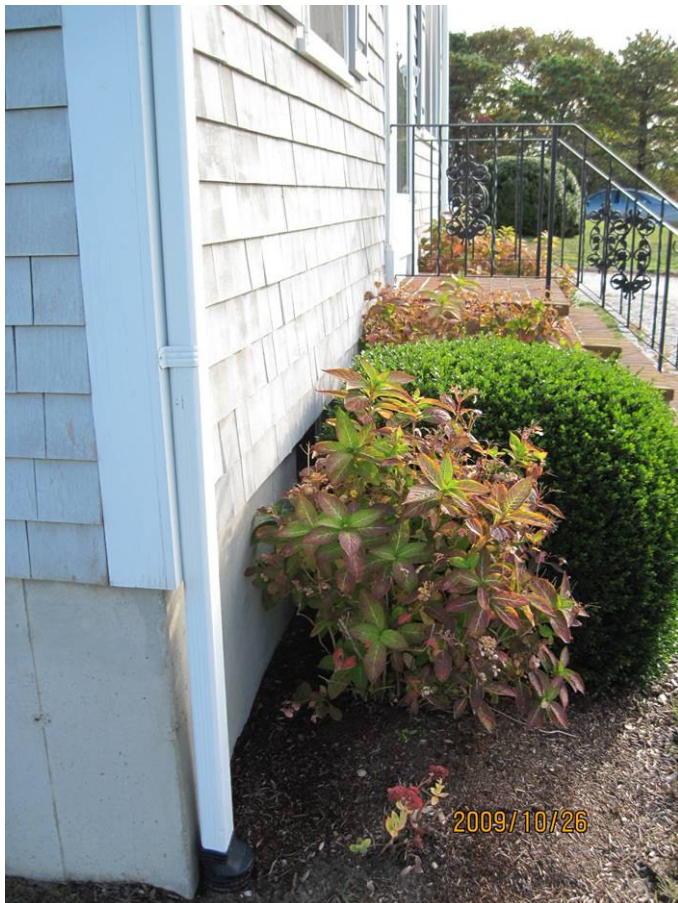
- Most of the downspouts terminate in piping that appears to go to drywells (see photo). It is not easy to tell whether drywells are still functional. They do “age” and can become plugged with gravel washing off the roof over the years.
- The shrubbery is growing too closed to the building (see photo) to allow proper ventilation and drying.

Downspout that appears to be heading to a dry well and vegetation too close to the building.

To improve the drying of the building, trim the vegetation so there is *at least* a foot clearance from the building to allow better ventilation and drying.

- Clean and maintain the gutters and downspouts to ensure removal of water from the foundation
- Become familiar with the suggestions in Mold Survival Guide for Your Home and Your Health by Jeff May.
