Nauset Environmental Services, Inc.

NES Job #899 Report No. NES/IAQ-15/1779

> Re: Post-remediation verification (PRV) inspection and sampling at 39 Easy Street (The Cape)

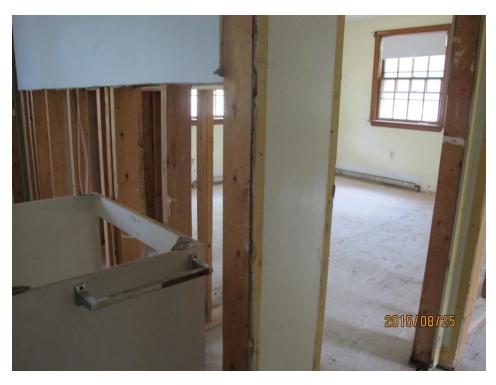
Looking into left, front bedroom over vanity from central bathroom

- The few contents on the main floor are appliances and should be removed and stored elsewhere and blown off with an air hoes and wiped down IF they will be retained. <u>The vanity should be discarded</u>.

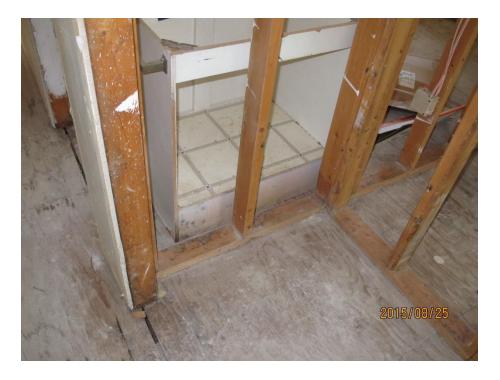
- There was VMG at two locations in the kitchen (see photos) and on a vanity that had reportedly been removed from the central, "blue" bathroom BUT not the house (see photo)

VMG on rear of vanity and on sill board

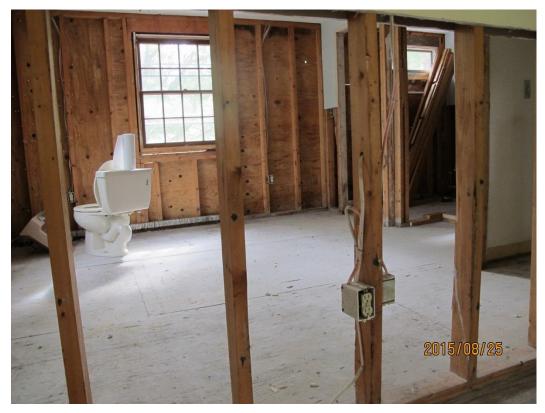
Left, rear bedroom off bathroom with leak

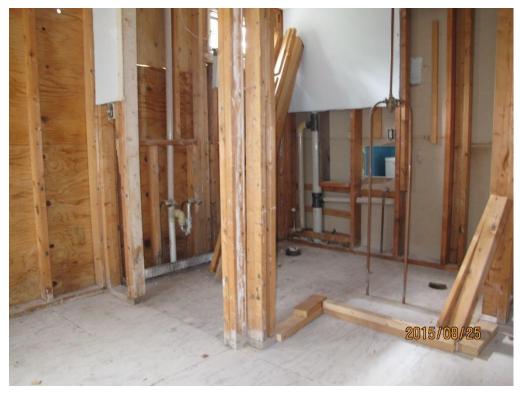
BACKGROUND: Reportedly, there was a pipe break in the left, rear bathroom in February that was not found (due in part to the harsh winter of weather, precluding easy visits) until April '15, caused extensive damage to the ranch house at this address. Some contractor selected by the insurance company carried out a water damage response, gutting the most of the left side of the main floor to the studs and also "treating the basement for mold." In light of recent observations of visible mold growth (VMG) in the kitchen and central bathroom, **NES** was authorized to carry out PRV mold inspection and sampling to prior to beginning reconstruction.

Bathroom where leak occurred at rear sink

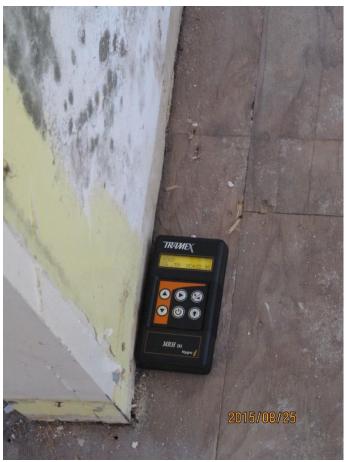
- Kitchen readings of 20-22% moisture content (MC) on the wood scale.
 - Central, blue bathroom readings of 22-25% MC.
 - Left, front bedroom readings of 20-21% MC.

Sub floor in kitchen reading22+% MC

- Operate <u>at least two</u> commercial dehumidifiers <u>on *each* level</u> to dry the structure till the wood frame, sub flooring, and joists read at least 18% MW at several locations, particularly the bedrooms and kitchen. DO NOT RELY ON RELATIVE HUMIDITY TO INDICATE ADEQUATE STRUCTURAL DRYNESS.
- Once returned to occupancy, see dehumidifier recommendation below.

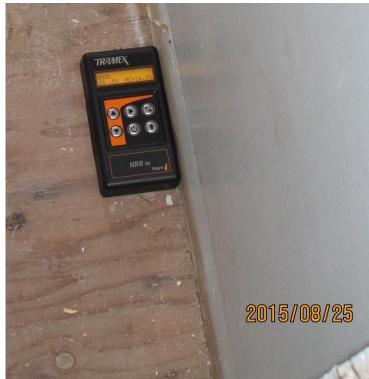
Subfloor in bathroom reading 24+ MC

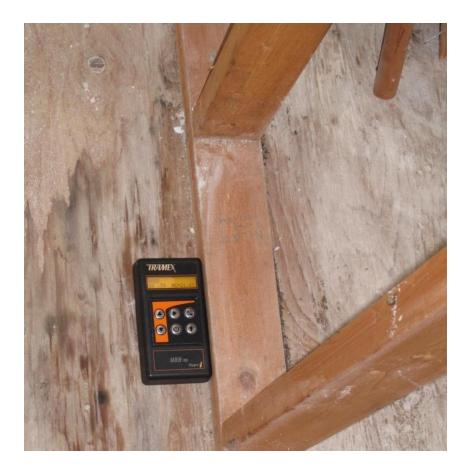
MM reading of 21+% MC in left, from bedroom

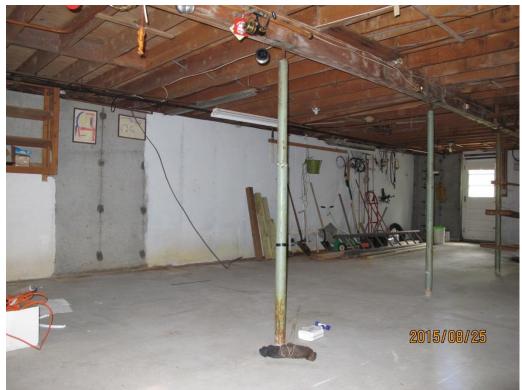
Basement – front wall

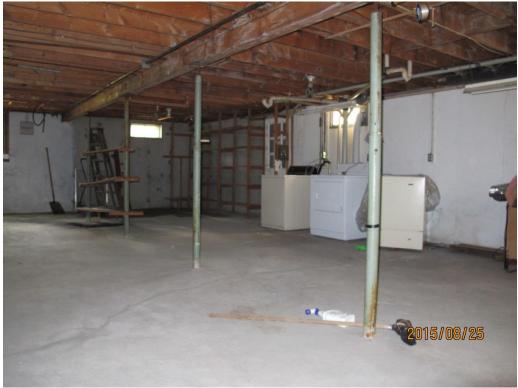
Basement – rear wall

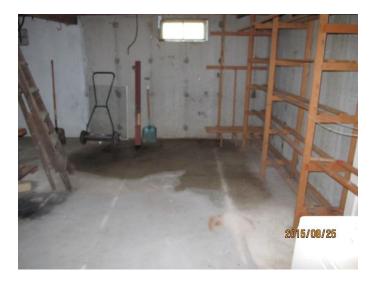
Puddle in Left, rear corner

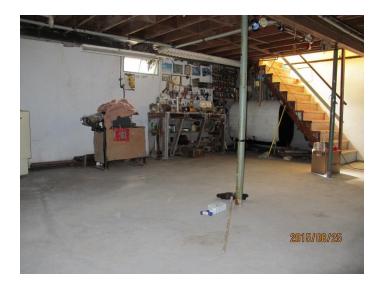
Right, rear corner under kitchen

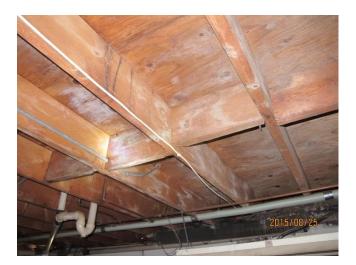
Visible mold growth

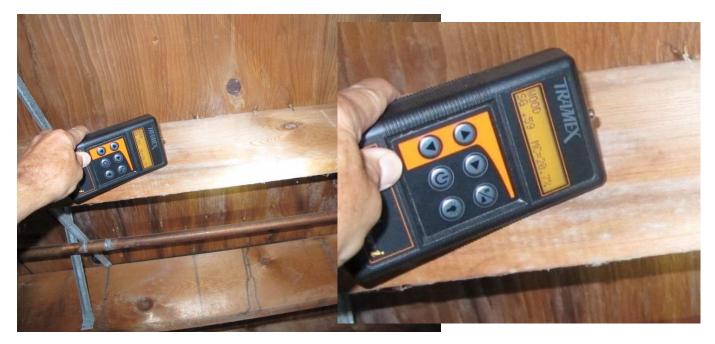
• MM readings indicated elevated reading above 18% MC in joists tested (see photos).

Unacceptable MM reading of 20.y% MC in joist

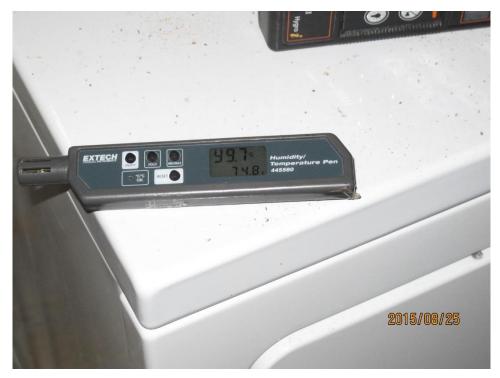
Elevated RH reading of 99.7% at 25F
