Nauset Environmental Services, Inc.

Report No. NES/IAQ-14/1597

Re: Mold/moisture inspection for knee wall attic
for 32 Riverside Drive (Taunton)

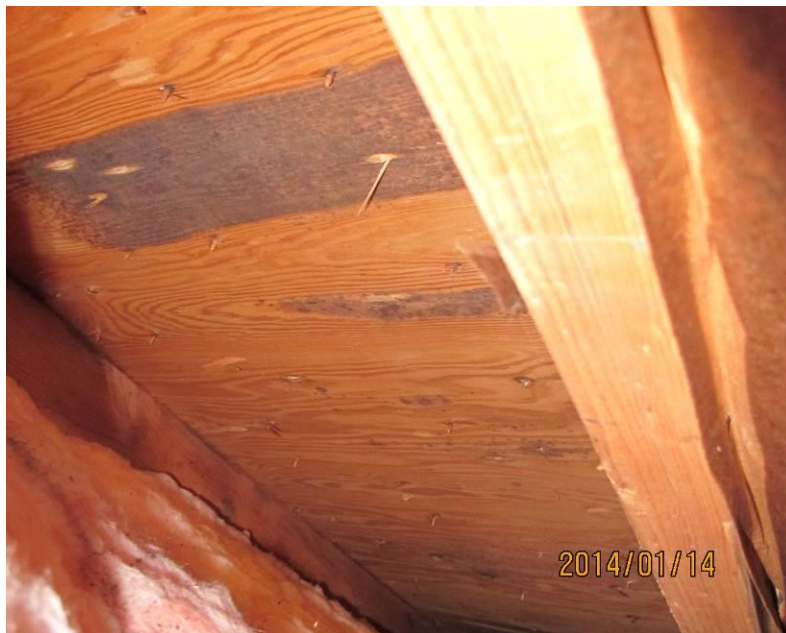
- ◆ Several the rafter bays on both sides of the front of the attic had gray to black staining of the plywood sheathing (see photos). On the right side knee wall (as viewed from the street) there was one a straight line of staining, marking the edge of a sheet of plywood (see photo), indicating a different history for that sheet compared to the adjacent sheets, NOT indicating a condition that was pervasive to the house (see discussion below). Rubbing these black, stained areas did not change the appearance of the area indicating that the condensation mold growth that led to the staining was *in the grain of the plywood* and thus not readily releasing spores. The staining was more irregular on other sections of sheathing on both sides of the attic knee walls and also not rubbed off (see photos).

Isolated areas of condensation mold growth (lumberyard mold) in right knee wall area

- Remove the existing backed insulation against the sheathing. If there is a desire to provide better insulation of these spaces, install un-backed fiberglass bats in the rafter bays.
- Install foam gaskets [e.g. Frost King foam tape) around the door frames to reduce the entry of warm, moist air into these spaces.
 - To reduce heat loss through the doors, install rigid foam insulation on the back side of the doors.
- Improve ventilation of these areas by adding small vents at the ends of these spaces.

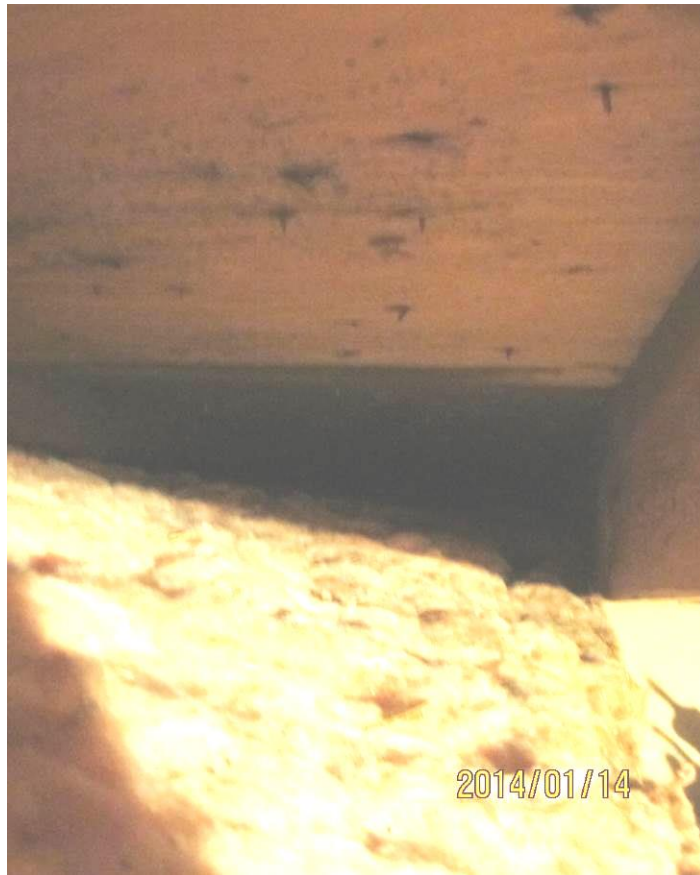
Straight line lumberyard mold growth indicating a sheet of plywood with different history from neighbors

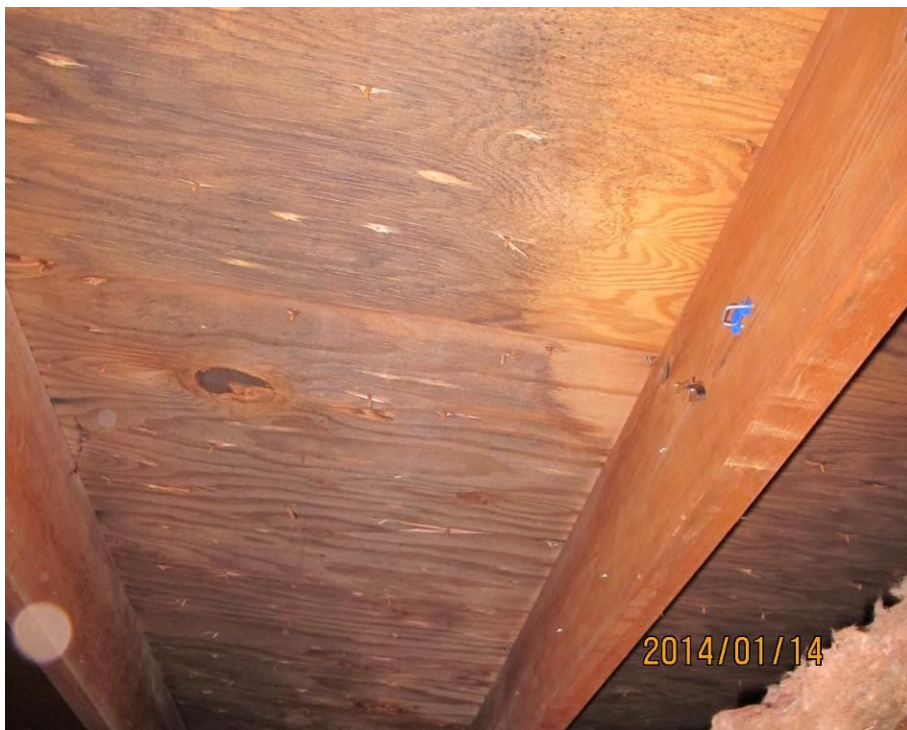
The cat’s eye pattern of clear grain often observed around nail penetrations is an indication of inhibited mold growth as the zinc has dissolved off the nails as water condenses on the nails and then wicks sideways in the grain. This observation is another indication of the thin layer of mold growth in the grain has not penetrated into the sheathing beyond that very thin layer of damp surface impacted by the condensation. If a newer roof has been placed over darkened sheathing, there will sometimes be splinters that show clear wood just behind the surface darkening, again demonstrating the shallow depth of this mold growth.

Lighter in-grain mold growth on left side [NOTE cat's eye pattern discussed in Attachment B.]

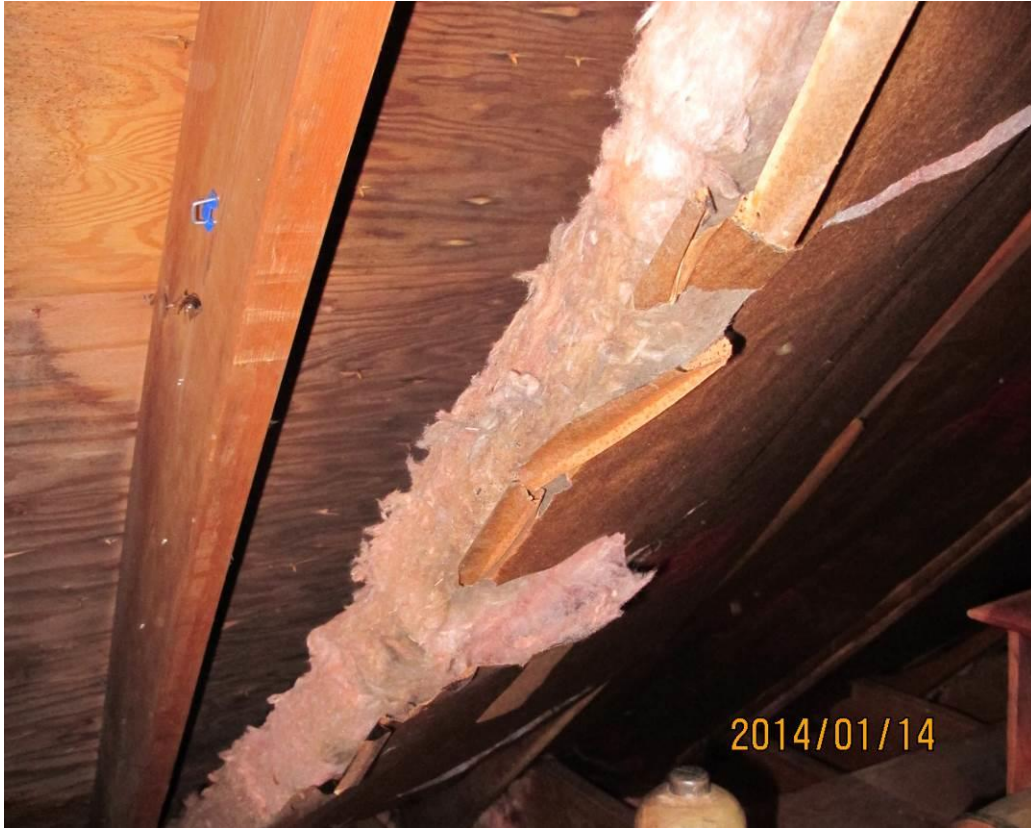
- ◆ There was gray to dark gray discoloration along the edges of the fiberglass insulation (see photo) installed against the sheathing. This discoloration is due to the filtering of the air that moves back and forth through the gaps between the insulation and the rafters. The filtered dust and particles are limited to the edges and are NOT mold growth.

Gray material (dust/particle) at edge of insulation on left side

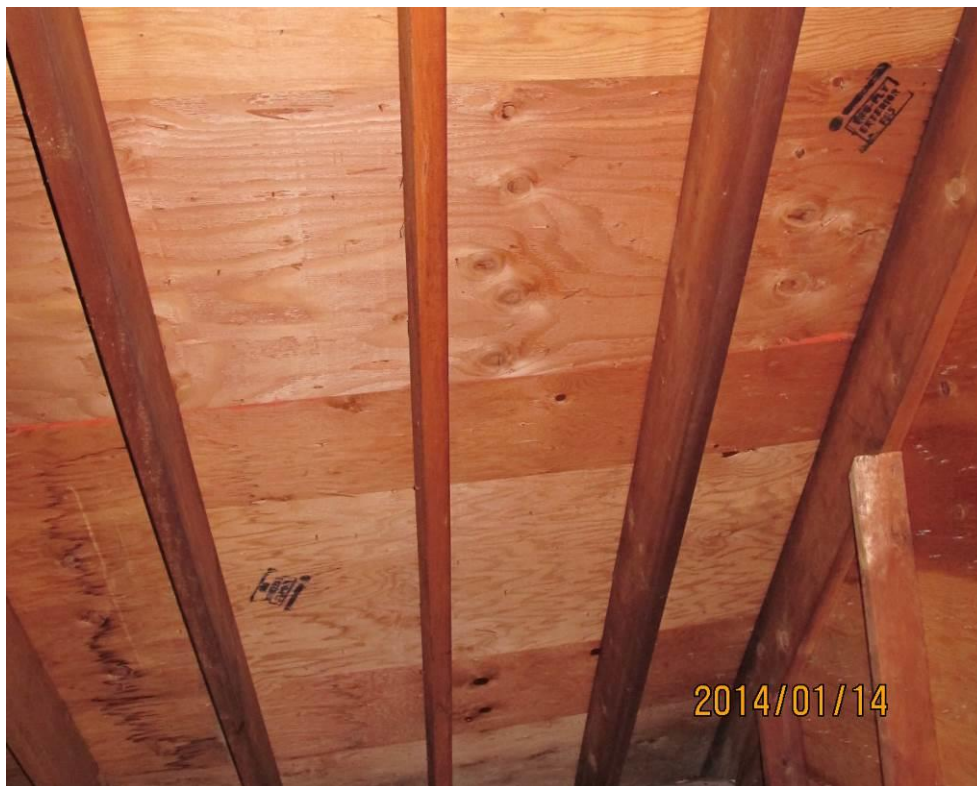
- ◆ There was staining and discoloration on the garage ceiling. Inspection of the attic space above did not reveal any indication of staining of the sheathing or leaking that might have led to the staining in the garage (see photos). [Note that the front roof sheathing in the garage is free of the lumber yard growth (see photo) found in the knee wall areas on the same northwest facing side. This observation is related to the absence of occupied spaces adjacent to the garage attic that would leak warm, moist air into that attic.]

Right, rear of garage roof showing no signs of leaks that would have impacted garage ceiling

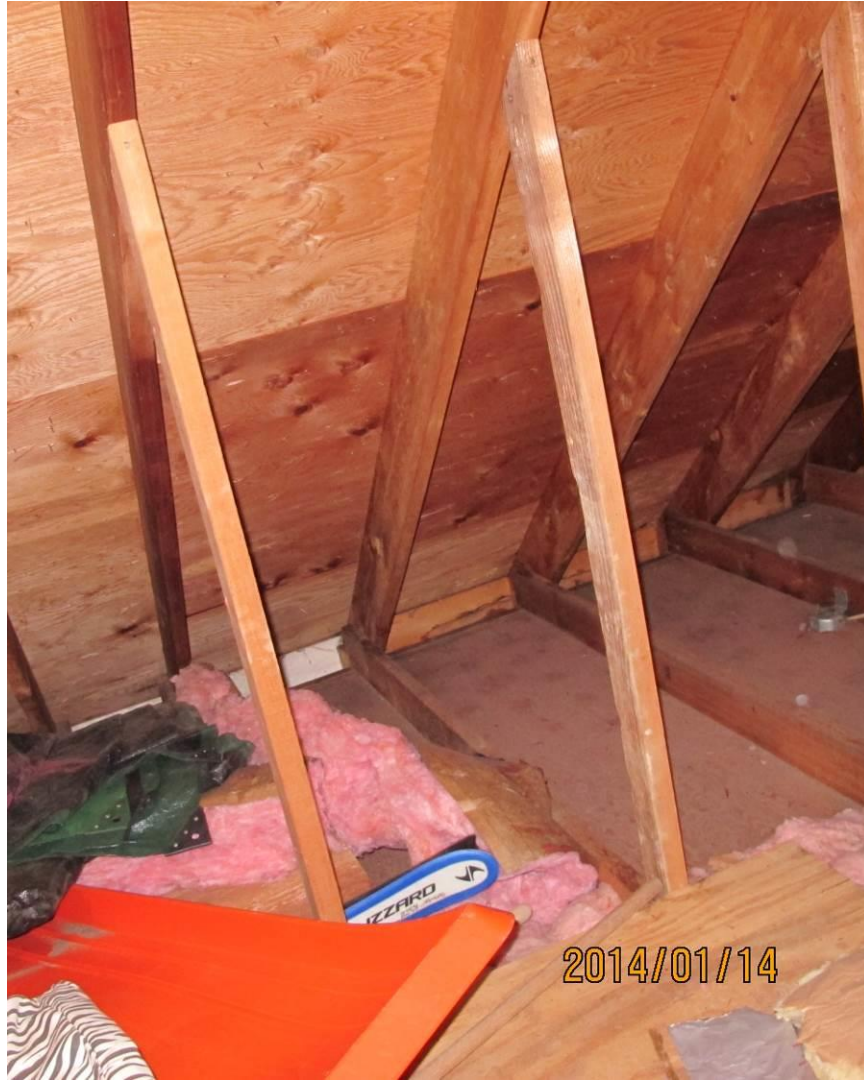
Front of garage room showing clear grain, nothing like the knee wall sheathing that was adjacent to occupied space where condensation on comparable surfaces supported in-grain mold growth
