Nauset Environmental Services, Inc.

NES Job #3-1585
Report No. NES/IAQ-14/1596

Re: Mold/moisture inspection with Scope of Work (SOW)
at 930 Cheyanne Road – St. Theresa’s Church (Weston)

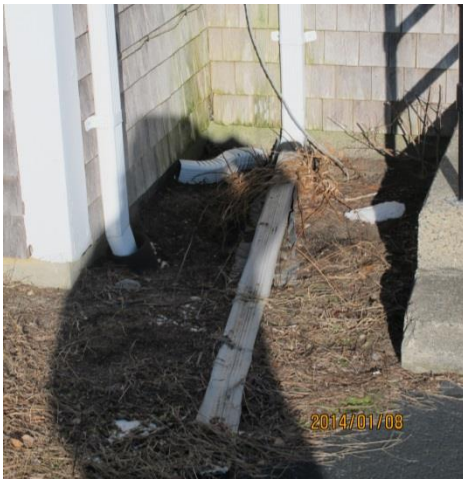
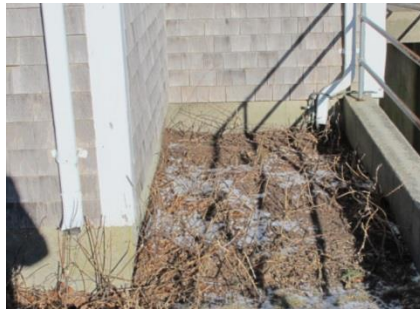
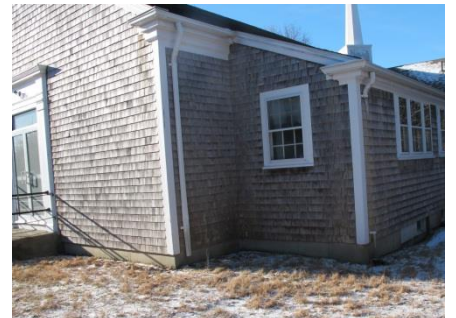
- Several of the downspouts at the south and east end of the building were improperly discharging water close to the foundation (see photos) such that water could pool and penetrate into the lower level, increasing damp conditions.
- There were wood-framed windows on the south and north side that had rotted (see photos) enough that water could leak into the lower level hall and pool there (see further discussion below). These windows also had obvious gaps/openings that allow outdoor air to enter the lower level.
- There were a couple of open vents into the crawlspace below the altar that exchanged air with the lower level (see photos) elevating the moisture level and leading to increased potential of dew point condensation on cooler surfaces, especially in summer months (see further discussion below).

Improperly installed/maintained downspouts that allow water to be discharged at the foundation

There are several improperly installed and non-functional downspouts on the building that need attention because they are adding water to the foundation where it can seep into the space. Improve the installation of the downspouts by:

- Installing functional drywells

Or

- Terminating downspouts 1.5-2 feet from the ground
- Adding an angled elbow
- Installing an extension to discharge at least four to five feet from the foundation
- Avoiding easy disturbance of the extended downspout segments by pop riveting or screwing them together, NOT just pushed together.

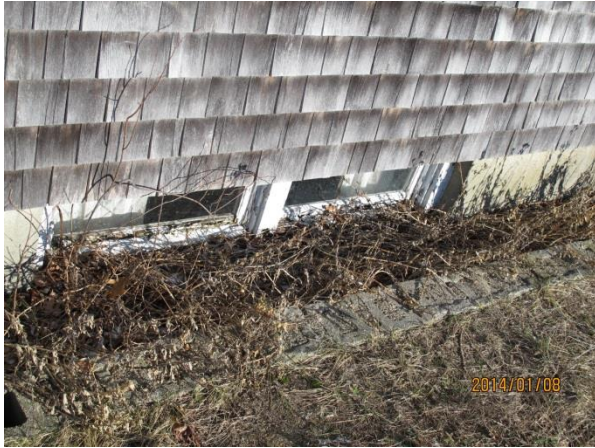
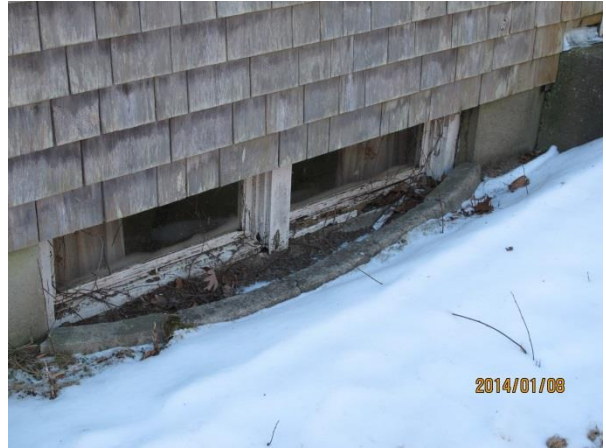
Rotted windows that allow water and outside air to enter the lower level hall

- Replace the rotted windows.
- Ensure that the window wells are protected from the weather so that water does not accumulate there to add to water intrusion.
- Replace the south door and ensure that the drain at the bottom of the stairs leading to it is functional so that water will not accumulate there in a dam and seep into the lower level.

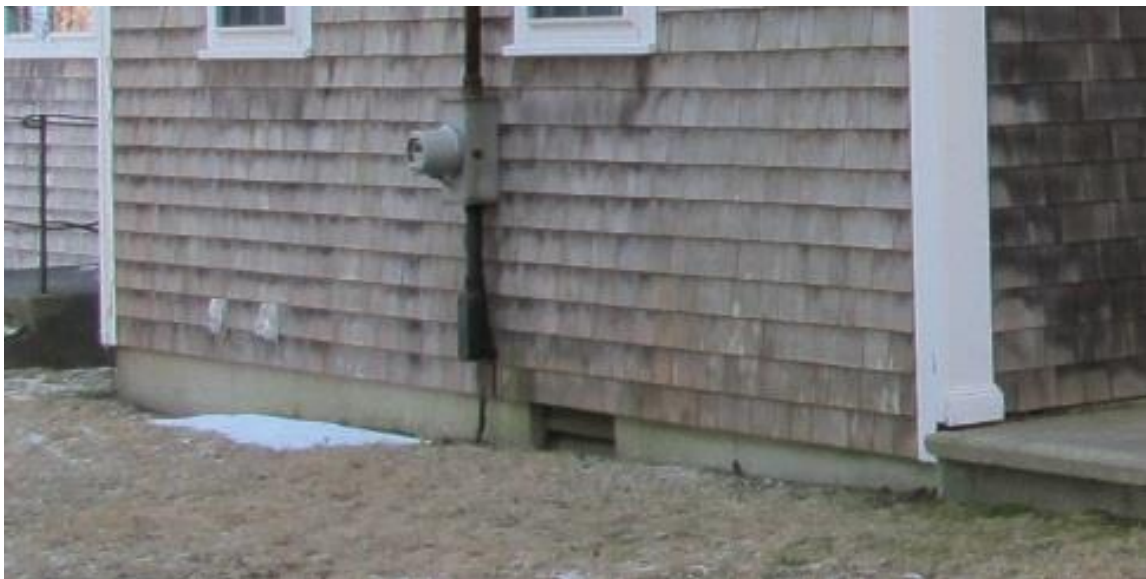
- ❖ The sources for the entry of this high dew point temperature air are the gaps/leaks around the lower level windows and the vents into the crawl space at the west (street side) end of this space and under the altar area (see photos). These vents were thought to “ventilate” the area with fresh air BUT are now understood to allow high dew point temperature air enter the space during summer months leaving copious amounts of condensation on surfaces cooler than the dew point temperature and supporting CMG on surfaces that have a coating of organic matter. [For perspective, in the summer of 2013, the Cape experienced several weeks of elevated dew point temperatures including an extended period of 70+ F dew points that would have condensed on the cooler surfaces of the crawl spaces and foundation walls in contact with the ground.]

North side vent into the crawlspace under the altar

- Close the vents to prevent high dew point temperature (i.e. high relative humidity) air from entering the interior.
- To reduce evaporation of soil water into the crawlspaces:
 - Cover the soil in these spaces with at least 10 mil plastic sheets.
 - Overlap the sheets by about two feet.
 - Secure the sheets in place with tape to minimize disruption by workers needing access.

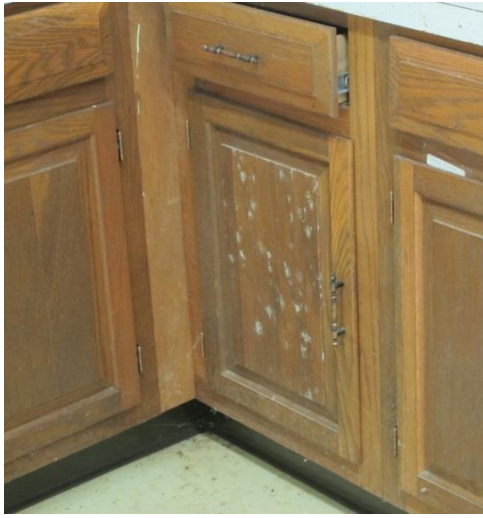
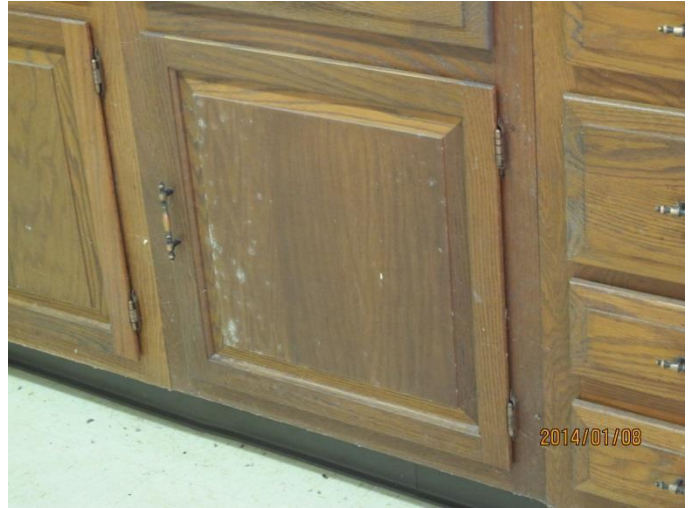
- There was light, white condensation mold growth (CMG) on the kitchen cabinet doors on both sides of the “passage” (see photos) through the kitchen area.

Light CMG on kitchen cabinets (on either side of passage)

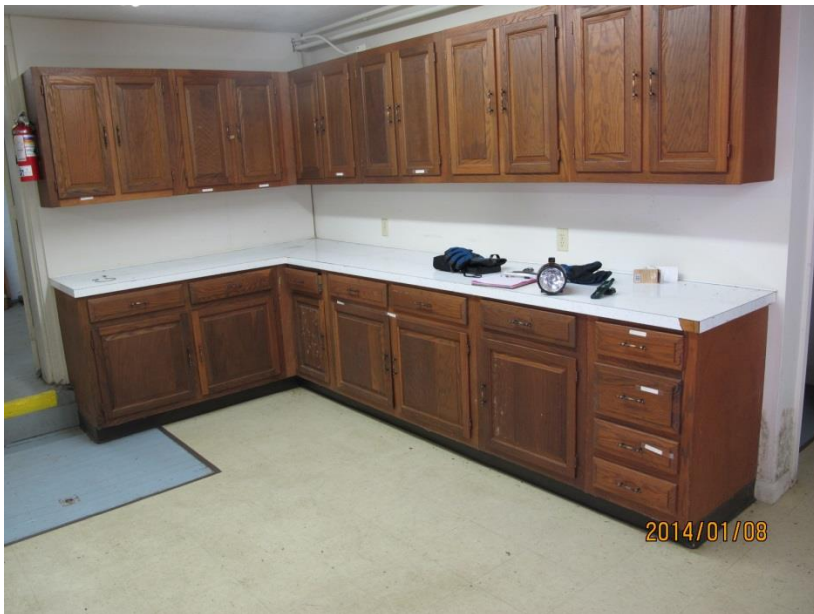
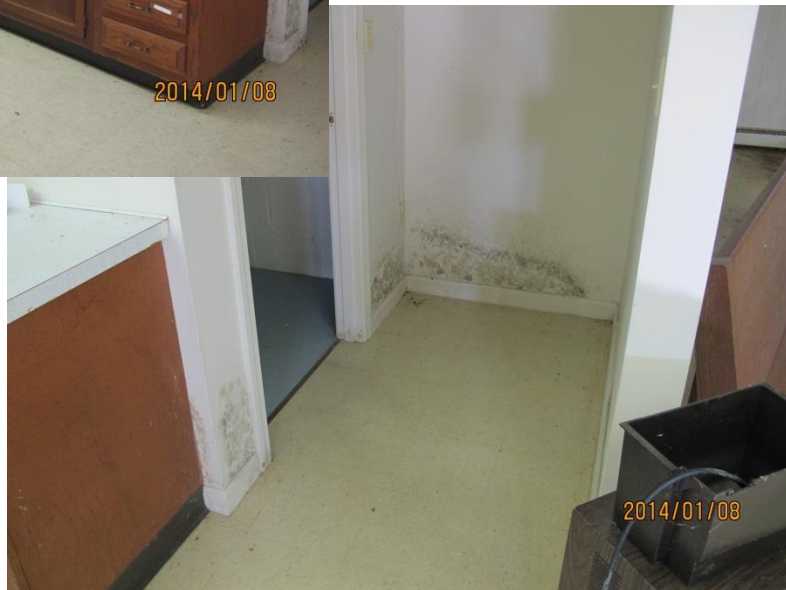
- There was heavy VMG in patches in the kitchen area – along the lower south wall where a large cabinet had been removed, in the area where the refrigerator had been (perhaps associated with a leak) and across the “passage” on the north side where the kitchen cabinets back on the ladies room wall that appears to have been impacted by a leak on the floor that wicked up into the drywall (see photos). VMG on wet drywall resulting from a leak is referred to as **Condition 3 contamination**, calling for professional mold remediation.

Cabinets on south side of “passage” backing on Ladies bathroom with VMG evident –suspect hidden mold growth as well

- Remove the cabinets in both areas to expose drywall that may be impacted behind them. [The removal on the north side will likely reveal hidden mold growth in the wall cavity shared with the ladies room with the ladies room.]
- Remove the lower 2-3 feet of drywall near any VMG. Continue removal until at least two feet beyond the last VMG to ensure removal of latent colonies near the edge of leak-impacted areas.
- HEPA vacuum ALL exposed surfaces in these areas to address the CMG as well, while the air scrubbers are still operating.
- Treat the more impacted areas with a peroxide spray application, or equivalent.
- Seal heavily impacted reaming to isolate any residual mold structures.

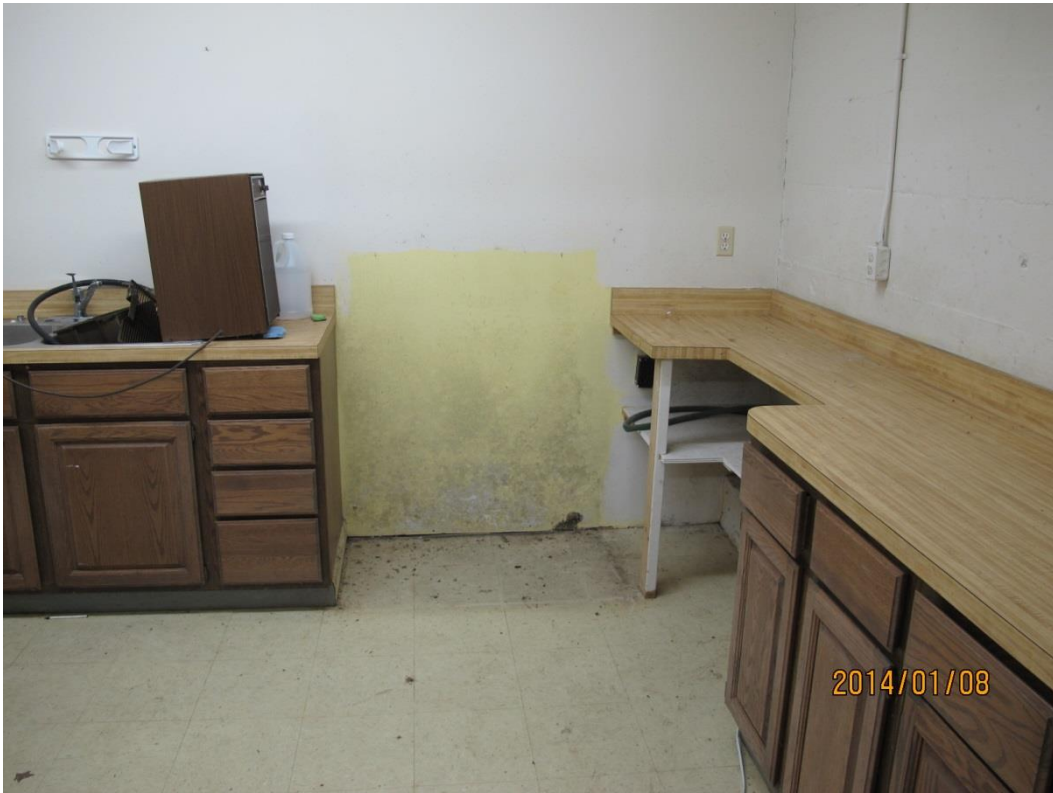
CMG on surface of wall behind former cabinet location with VMG near floor

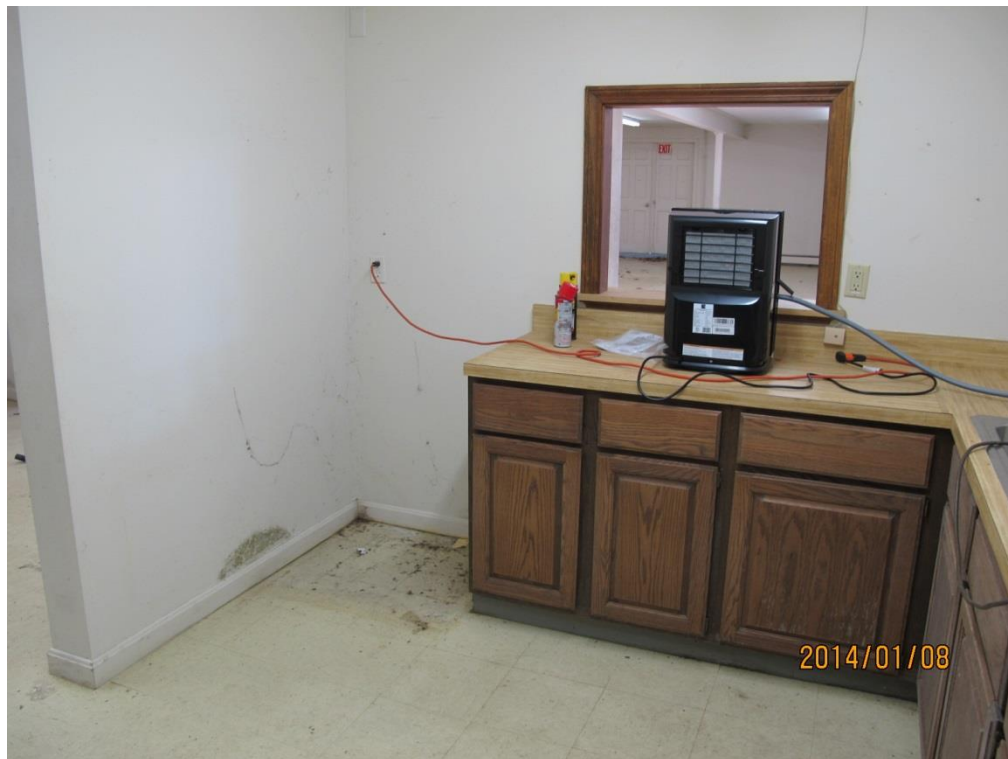
VMG near former refrigerator location, indicating possible leak

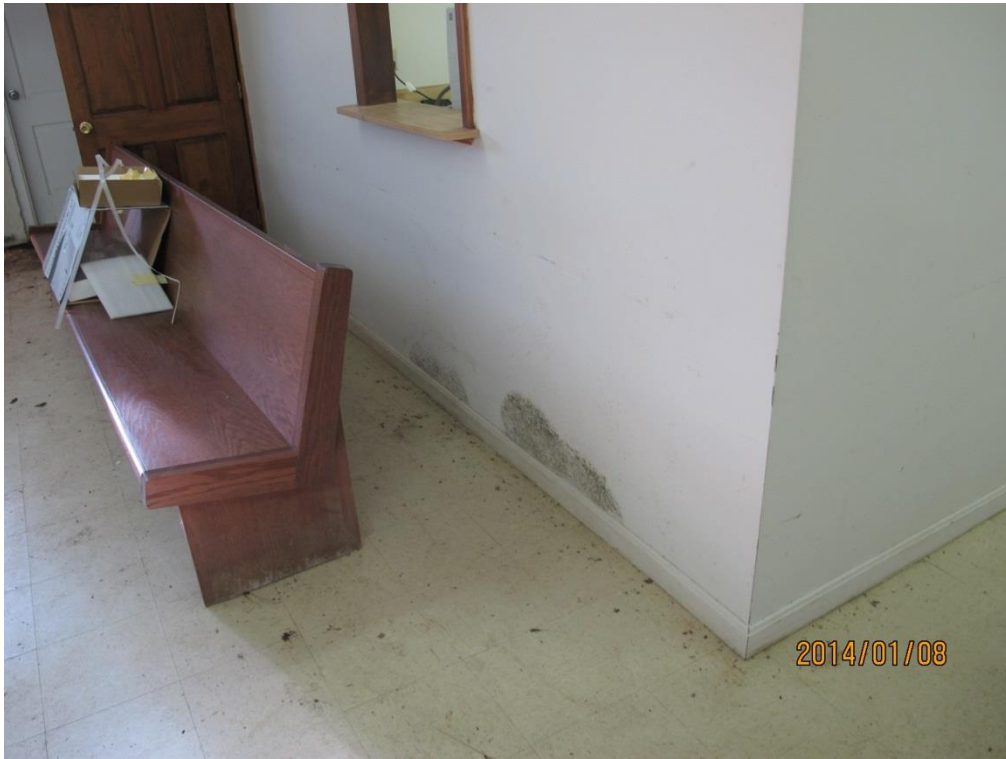
- There were isolated areas of heavy VMG on the wall backing on the kitchen (see photos), perhaps linked to leaks in the kitchen from the refrigerator or sink.
- There was also extensive CMG along the walls, especially the north wall (see photos), where high dew point temperature air had condensed (see discussion above).

Back side of kitchen wall (see above) near refrigerator corner

- The activities above associated with the kitchen will also address its common wall with the main room.
- In the closet off the south door
 - Remove the shelves and examine for hidden mold VMG in the drywall behind those shelves
 - Remove the lower 2-3 feet of drywall near any VMG. Continue removal until at least two feet beyond the last VMG to ensure removal of latent colonies near the edge of leak-impacted areas.
 - HEPA vacuum ALL exposed surfaces in this general area to address any CMG as well, while the air scrubbers are still operating.
 - Treat the more impacted areas with a peroxide spray application, or equivalent.
 - Seal heavily impacted framing to isolate any residual mold structures.
 - Seal the sill board/floor gaps with flexible caulk to isolate these hard to dry/clean areas

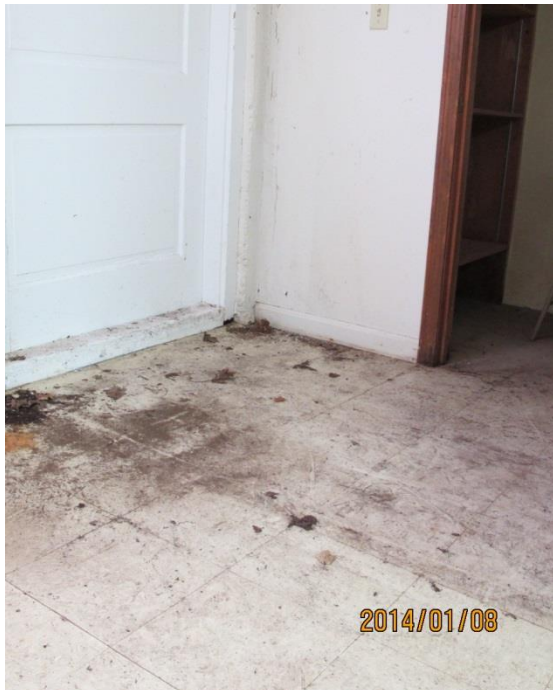
- The south window leak led to staining on the painted concrete wall (see photo).
- There was evidence of leaks near and under the south door (see photo) that had led to some VMG in the main room and likely hidden mold growth behind the shelf assembly in the adjacent closet, also referred to as **Condition 3 contamination**.

Indication of leaking under south door leading to puddling that affected pew stored nearby (see below)

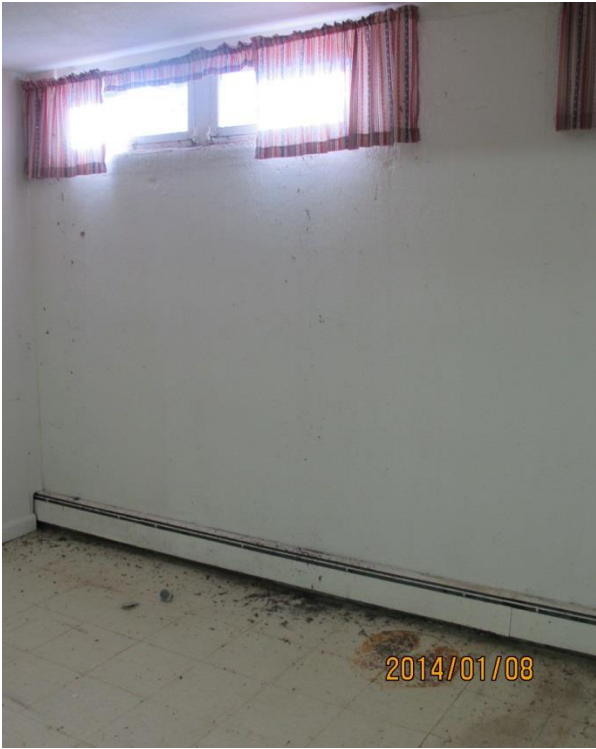
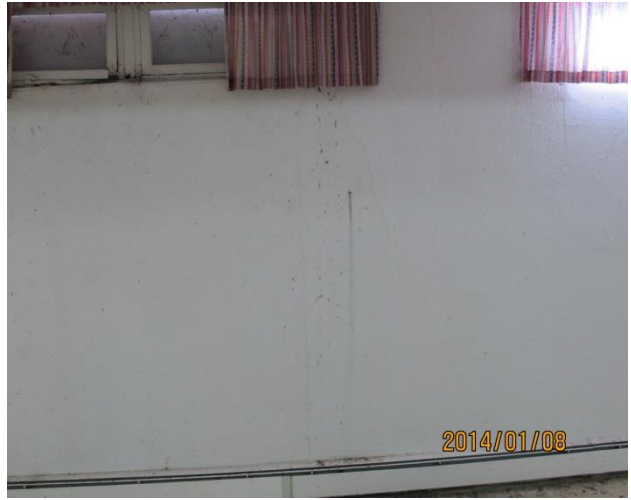
Leaking windows along south wall adding moisture to the lower level

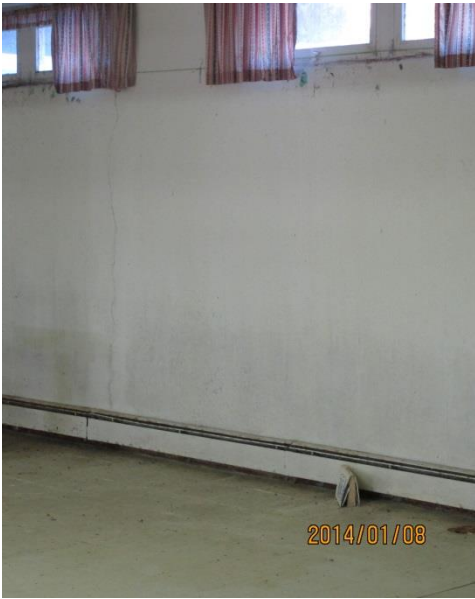
Haze of CMG along north wall

- HEPA vacuum ALL exposed surfaces in the main room to address the CMG, while the air scrubbers are still operating.
- Check and clean the small closet in the southeast corner

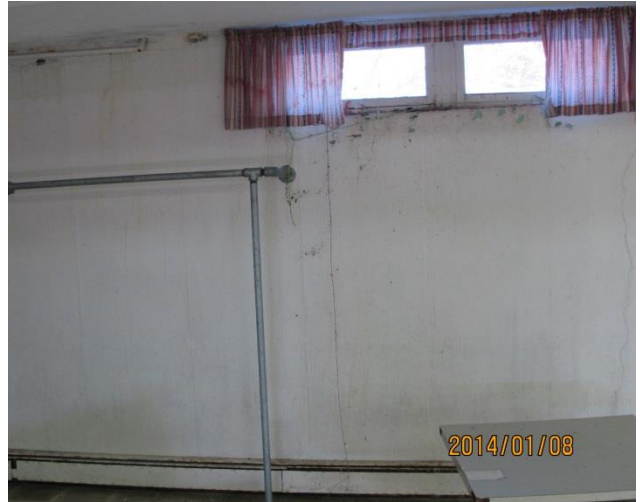
- There were evident leaks associated with the rotted windows on the north and south walls (see photos).
 - The north window leak led to standing water that was sufficient to spread to one pew stored nearby showing water staining, mold growth and wicking, to a center post table where its stand rusted and left a pattern on the floor (see photo) and toward the center of the west side of the area where VMG developed from wicked up water from the puddle (see photos).

Leaking window on north wall

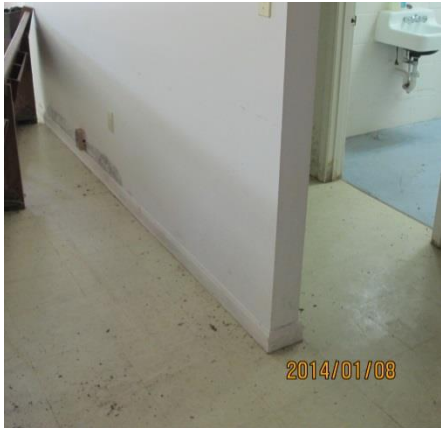
- The pooled water from the leaking north window drained toward the center where the bathrooms are located and wicked up into the drywall such that many areas near and leading into those bathrooms supported VMG (see photos).
- The dampness in the bathrooms also led to CMG on the upper levels of walls and doors (see photos).

VMG in main room near men's room

- Remove the lower 2-3 feet of drywall near any VMG. Continue removal until at least two feet beyond the last VMG to ensure removal of latent colonies near the edge of leak-impacted areas.
- HEPA vacuum ALL exposed surfaces in these areas to address the CMG as well, while the air scrubbers are still operating.
- Treat the more impacted areas with a peroxide spray application, or equivalent.
- Seal heavily impacted framing to isolate any residual mold structures.
- Seal the sill board/floor gaps with flexible caulk to isolate these hard to dry/clean areas

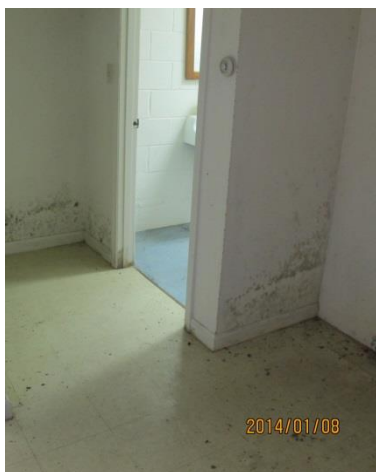
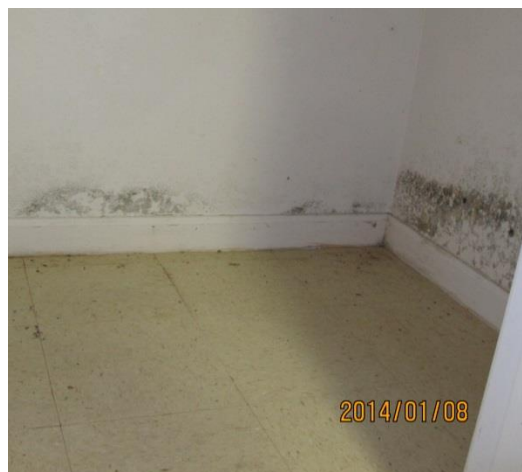
VMG outside men's room near north wall leak

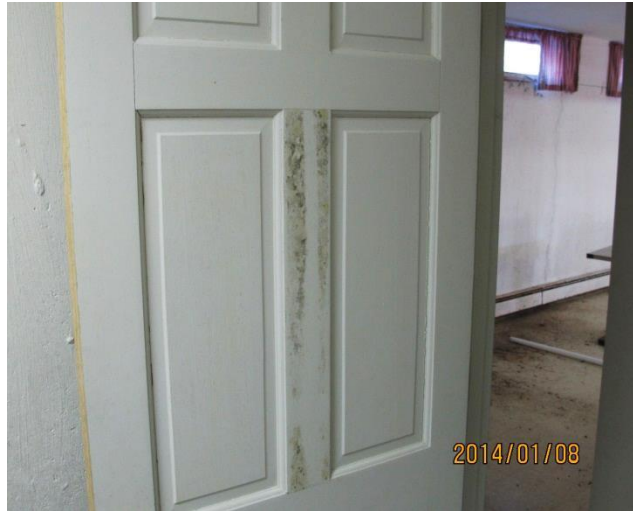
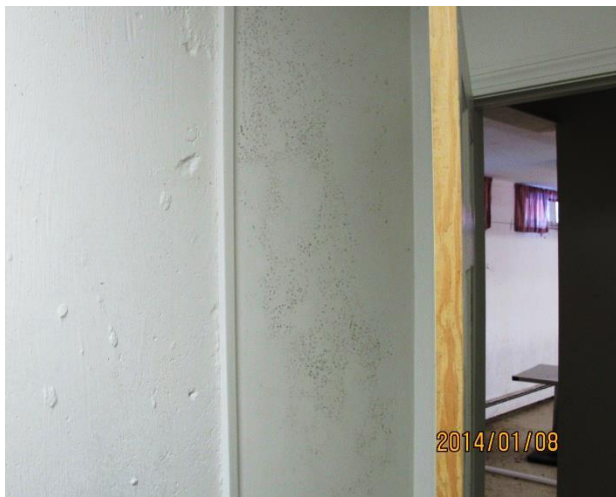
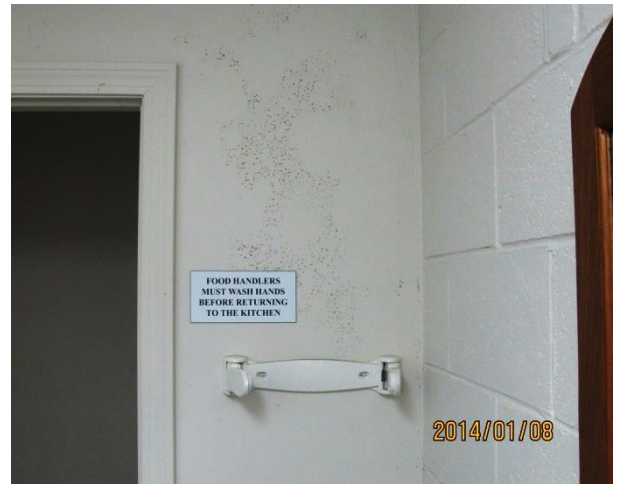
CMG on walls and door of men's room

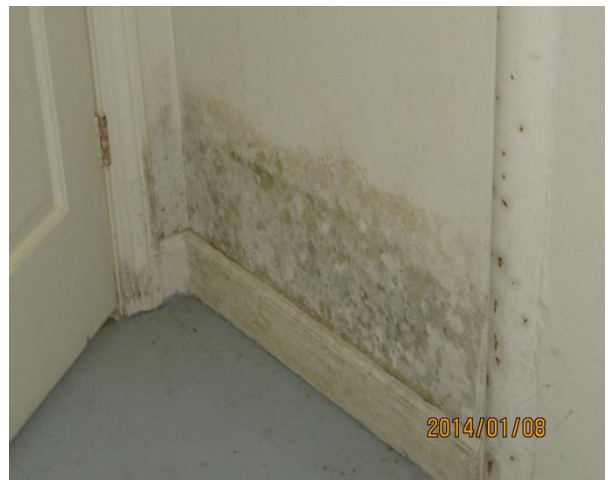
Behind ladies room door (backing on cabinets)

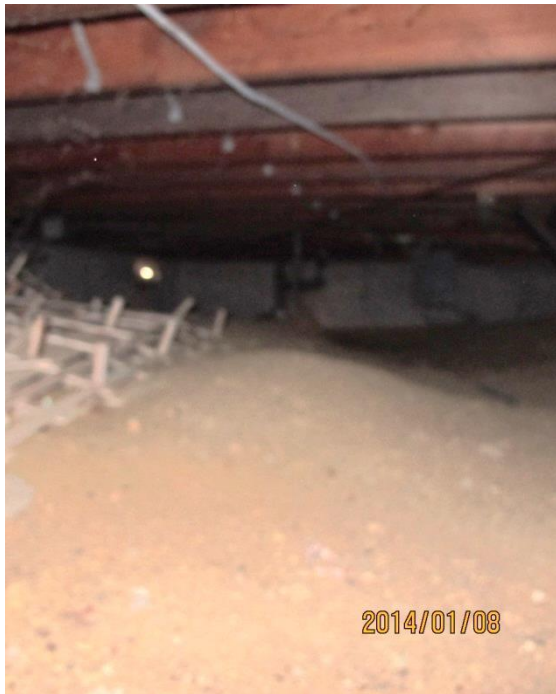
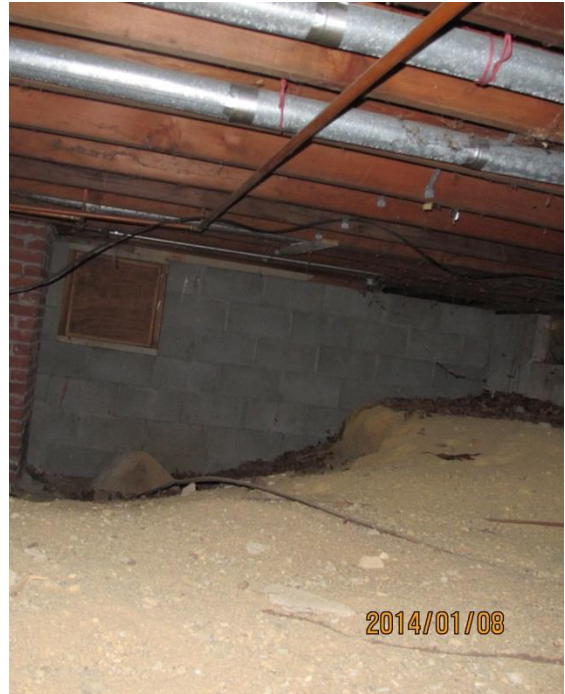
South and north crawlspaces under altar with vents allowing outdoor air to enter
