# Nauset Environmental Services, Inc.

NES Job #3-1517  
Report No. NES/IAQ-13/1554

Re: Mold/moisture inspection  
for 191 Old Town Road (Manchester)

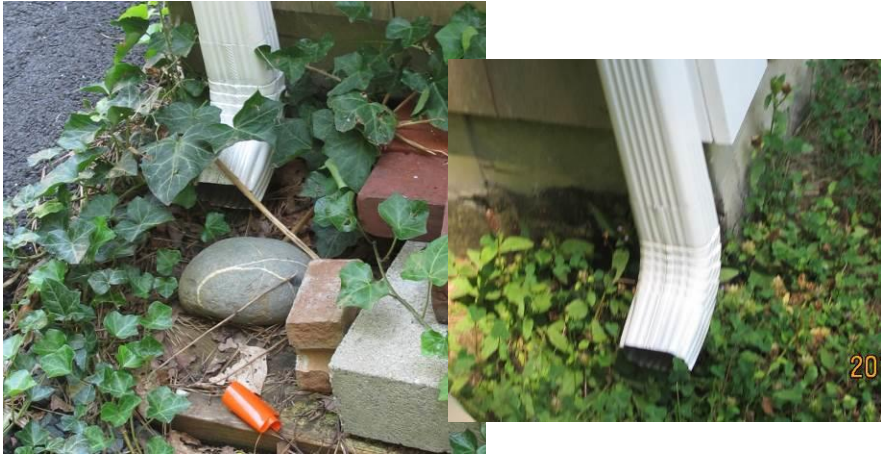
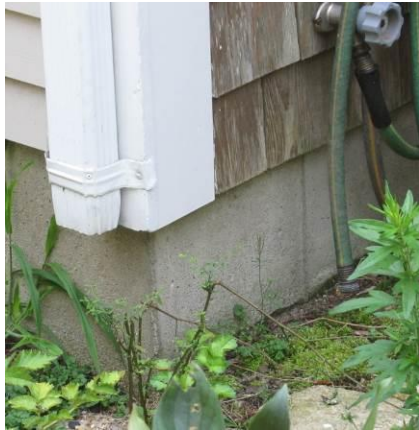
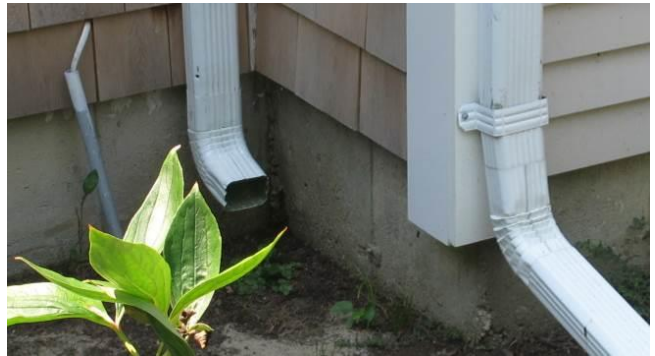
- The downspouts along the front and right sides of the house were discharging water too close to the foundation (see photos) allowing water to accumulate along the foundation with the possibility of seeping through the concrete or coming under the foundation, especially into the crawl spaces.
  - Improve the installation of the downspouts by:
    - Terminating them 1.5-2 feet from the ground
    - Adding an angled elbow
    - Installing an extension to discharge at least four to five feet from the foundation
    - Avoiding easy disturbance of the extended downspout segments by popping riveting or screwing them together, NOT just pushed together.
- The downspouts at the rear of the master bedroom addition discharge into piping that appears to lead to dry wells (see photos).

Downspouts discharging too close to the foundation

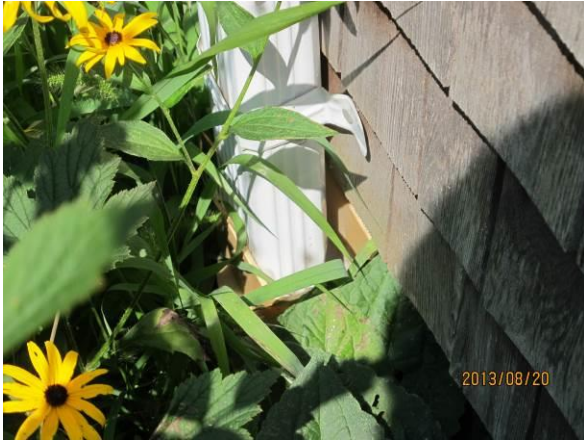
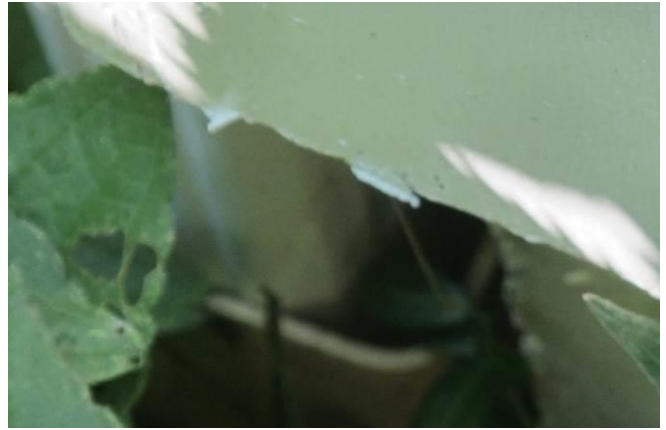
Downspouts at rear of left crawl space apparently discharging into drywells

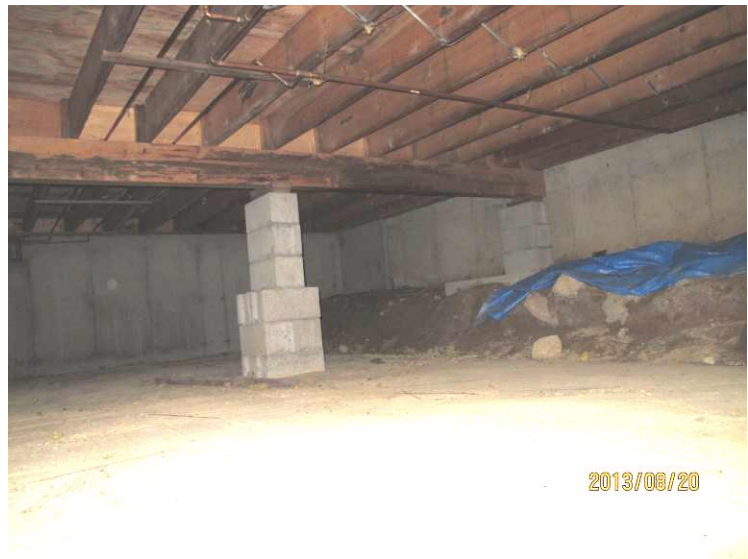
- This crawl space had a concrete floor along the right side with exposed dirt to the left against the foundation to avoid compromising the foundation structure (see photos). This dirt allows water to evaporate up into the crawl space. The dirt should be covered with a 6-10 mil vapor barrier to minimize moisture entry into the space.

View to left, front of right crawl space with exposed dirt against basement foundation

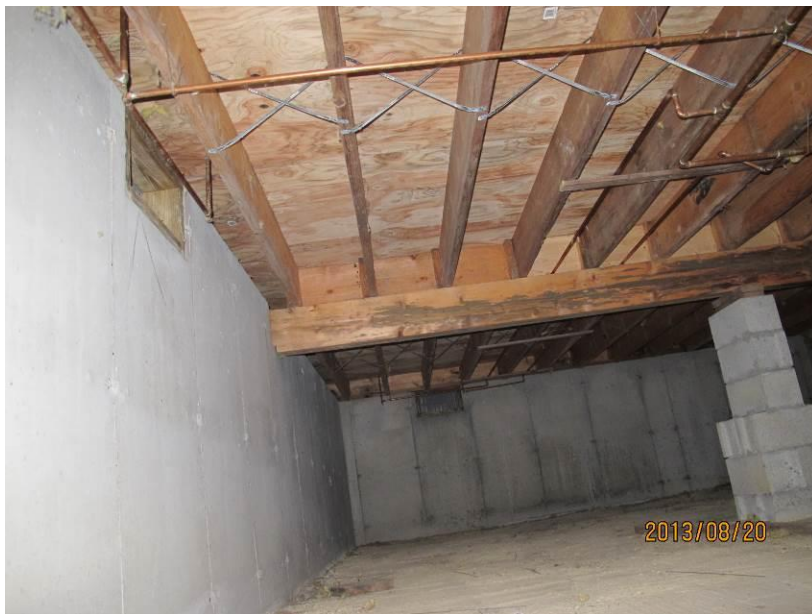
- There were two open vents into this crawl space under the master bedroom (see photos) that Mr. Jones closed during the inspection to minimize damp air infiltration. These vents should remain closed as noted for the right crawl space.

Viewing to left, front of left crawl space where two air vents are evident that should be closed

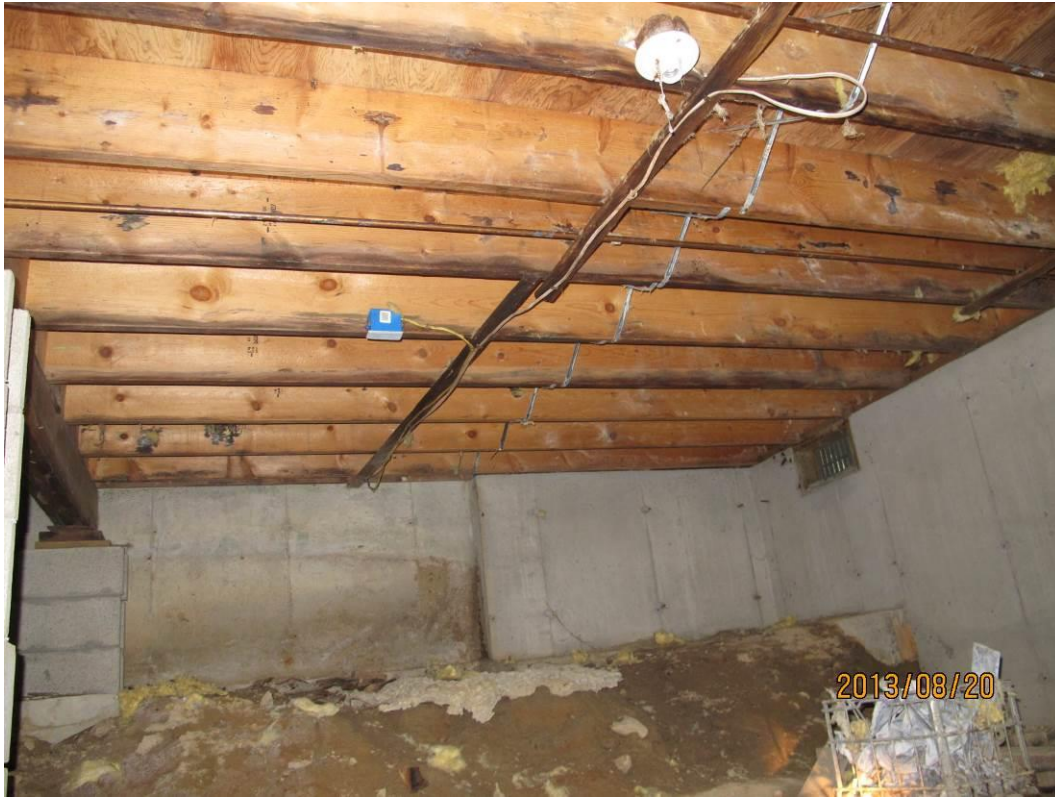
- There were air vents in the foundation (see photos) and wooden hatch. These openings let in the moisture that caused the fiberglass insulation to collapse under the weight of the condensed water. All air vents should be closed.

View of left, rear of right crawl space where a third vent is evident that needs to be closed

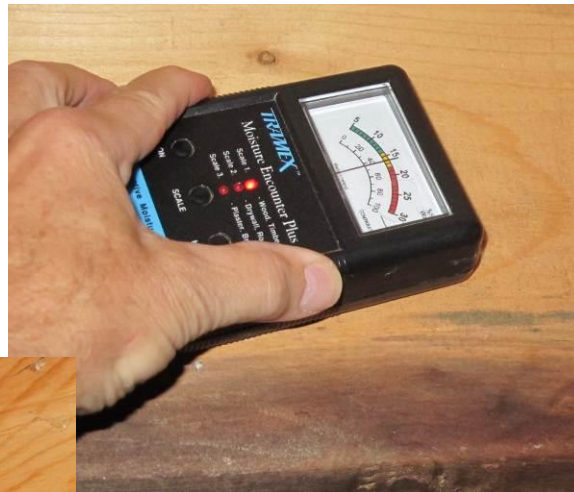
- The moisture meter (MM) registered an acceptable reading of 15-16 % moisture in wood (MW) on a joist near the access door (see photo) and where the dehumidifier had been operating.

Acceptable MM reading of 15-16% MW in joist

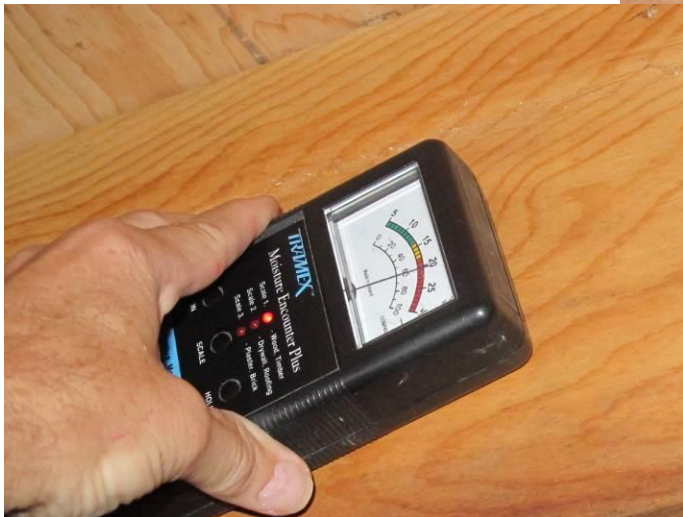
- The MM indicated 20-21+% MW in a joist near the middle of the crawl space (see photo). This unacceptable reading indicates that additional drying is called for, probably with the dehumidifier operating closer to the center of the space. [Mr. Jones relocated it several more feet into the space that the time of the in section.] Dehumidification should continue until MM indications at many locations are at least in the 15-18% MW range – NOT depending on the relative humidity of the air.

Unacceptable MM reading of 21+% MW in central joist

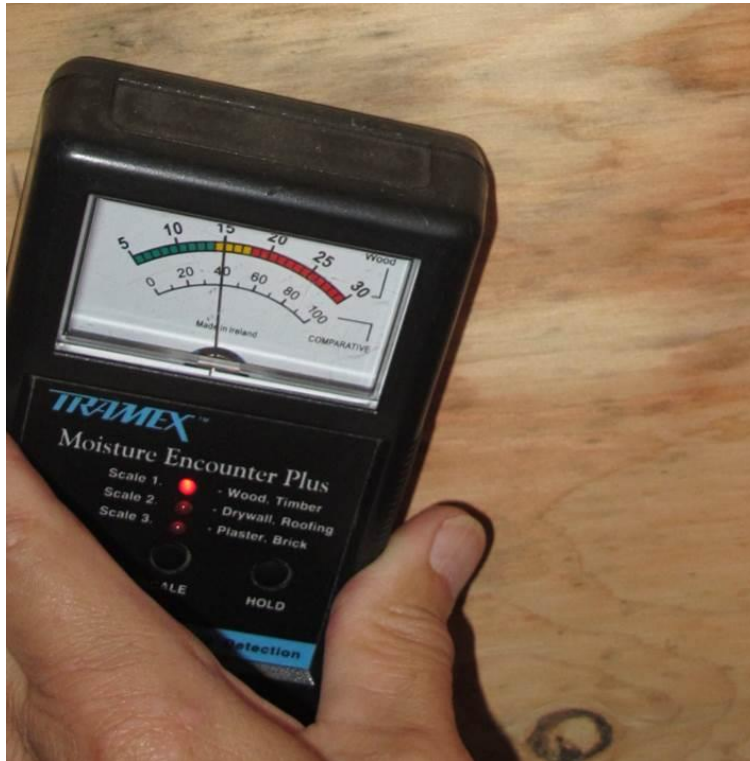
- The MM indicated an acceptable reading of 15-16% MW in subflooring in the middle of the space (see photo).

Acceptable MM reading of 15-16% MW in central subflooring

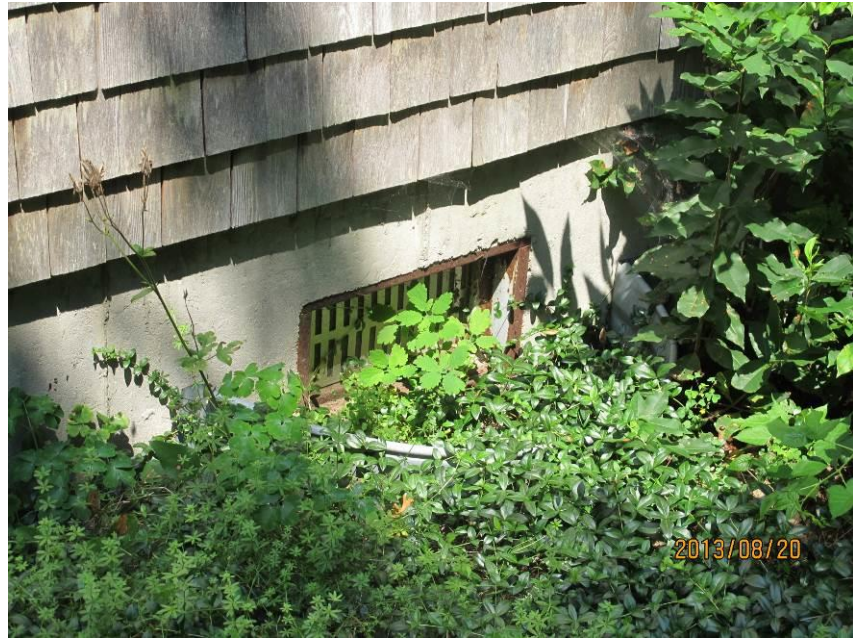
One of two air vents in to the right crawl space that was closed by Mr. Jones at the time of the inspection

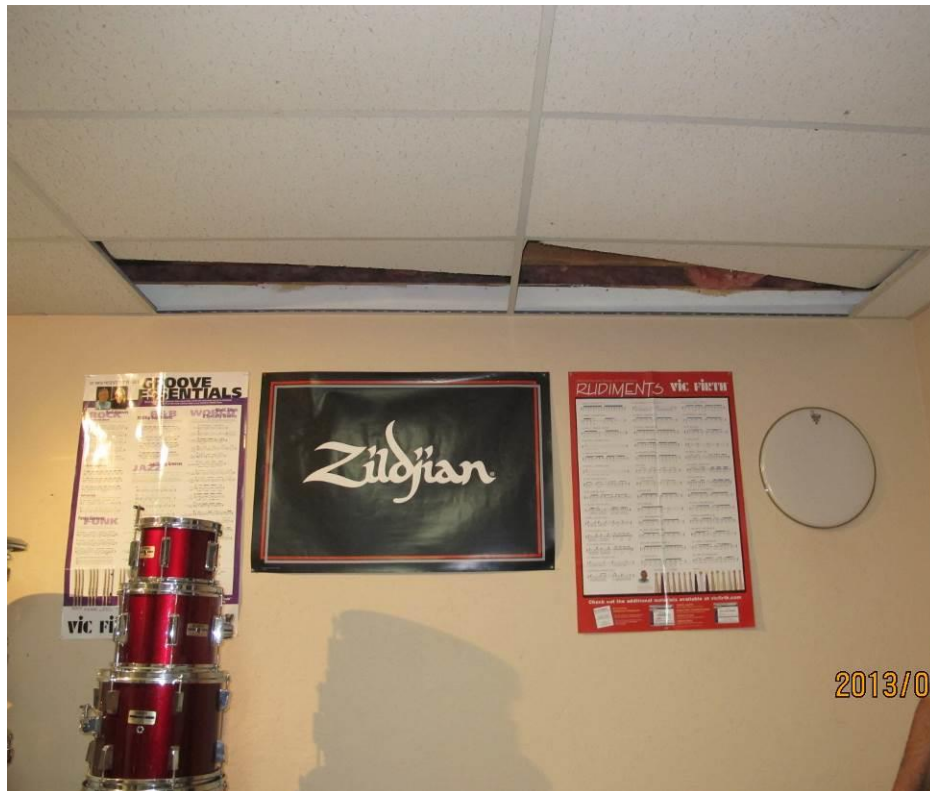
The challenge of assessing the inaccessible left crawl space (without disruptive inspection – see photo) was addressed by utilizing the sense of smell and instrumental readings. The MM was used to measure the relative dampness in a joist adjacent to the left crawl space and a similar joist one room further into the basement. Comparing the readings finds only slightly damper, but acceptable, conditions in the wood near the left crawl space compared to the wood on the left side of the basement a situation that implies no excessive dampness that would have soak the joist over time. In addition, without telltale odors in the master bedroom above and in the adjacent basement space, there is no indication that excess biological activity has been stimulated by dampness much less rodent activity.

Finished wall in basement against left crawl space  
[Unknown sized "access" is purportedly behind this wall, perhaps only a third air vent.]

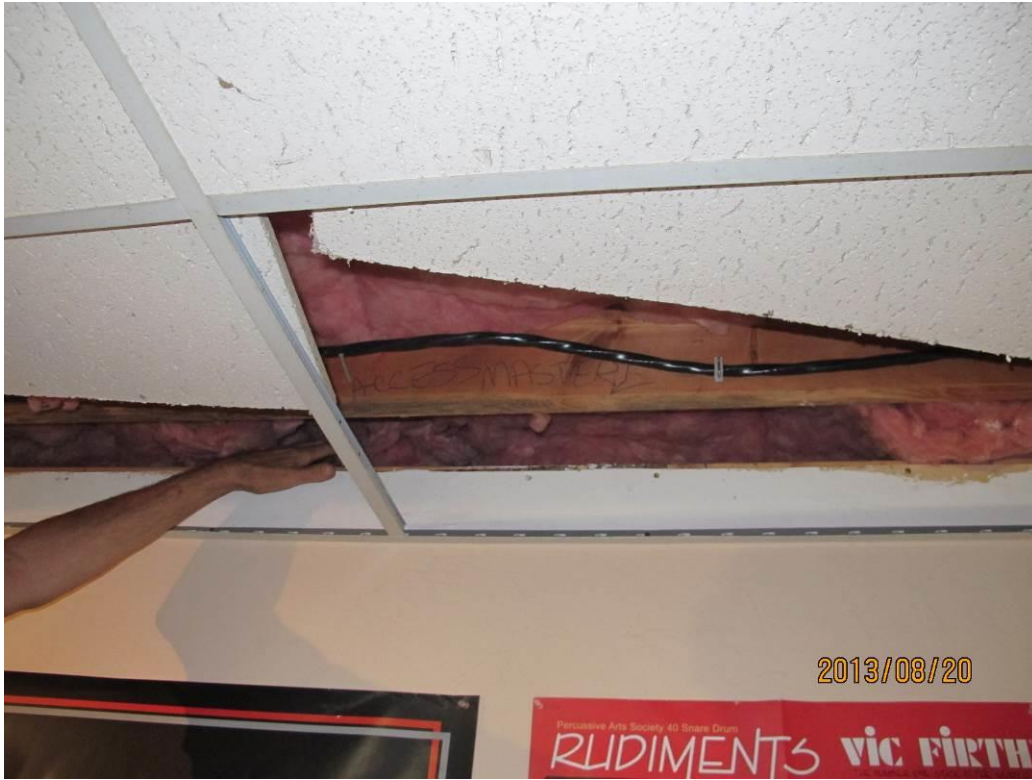
- The joist at the edge of the left crawl space registered 18-19% MW, a barely acceptable reading.
  - The comparison joist in the adjacent basement room registered an acceptable 10-12% MW.

Fiberglass was pulled back to make MM reading of 18-19% MW in joist backing on left crawl space
