Nauset Environmental Services, Inc.

NES Job #959
Report No. NES/IAQ-18/2222

Re: Post-remediation verification (PRV) mold/moisture inspection and sampling
at 10 Honeysuckle Way (Taunton)

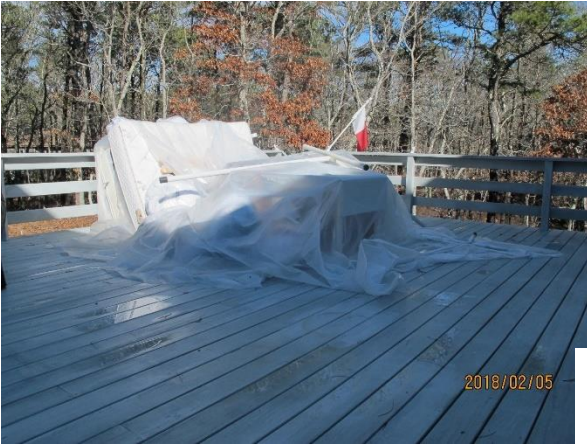
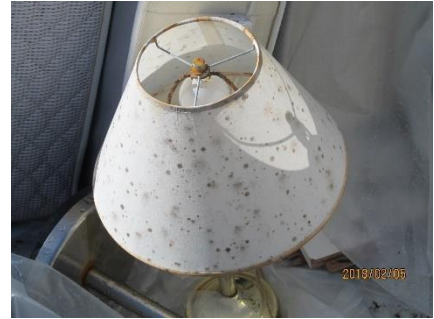
Contents removed from impacted areas

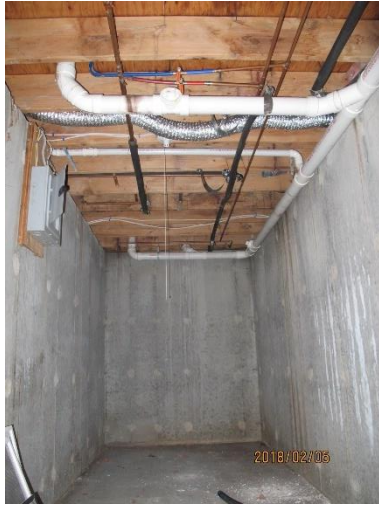
Under utility room

- The moisture meter readings in the basement were:
 - Subfloor under utility room – 16-17% moisture content in wood (MC) {marginal + see below}
 - Joists under utility room - 6-7% MC
 - Center – subfloor – 12% MC
 - Center – joists – 6-7% MC
 - Steps – side – 6-7% MC treads – 12-14% MC

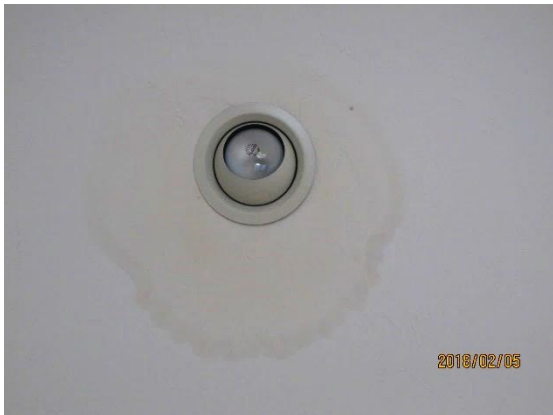
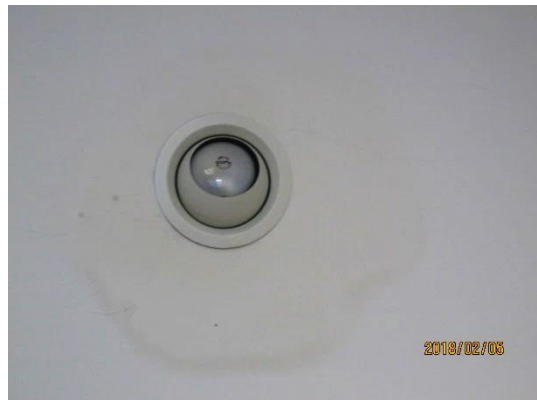
- The moisture meter readings were acceptably dry:
 - at several locations across the subfloor and near the utility room (left, rear) – 0-7% MC
- There was water staining around the recessed lights in the front ceiling (see photo). [If there had been no readily observable visible mold growth seen near the rear recessed light when the nearby drywall was removed, there should be no concern for VMG in the front ceiling. **HOWEVER**, if VMG was observed in the rear ceiling near those recessed lights, the front ceiling should be opened near these lights (see SOW below).]

Staining around front recessed lights

- Since there was water staining near the recessed lights at the front of the family room, there is a possibility that condensation water impacted the nearby drywall enough to support VMG. However, a similar situation existed on the rear ceiling that was partially removed. IF VMG was observed near the similar staining on the rear ceiling THEN the area around the front lights should be opened and examined; OTHERWISE no additional opening/removal is called for.

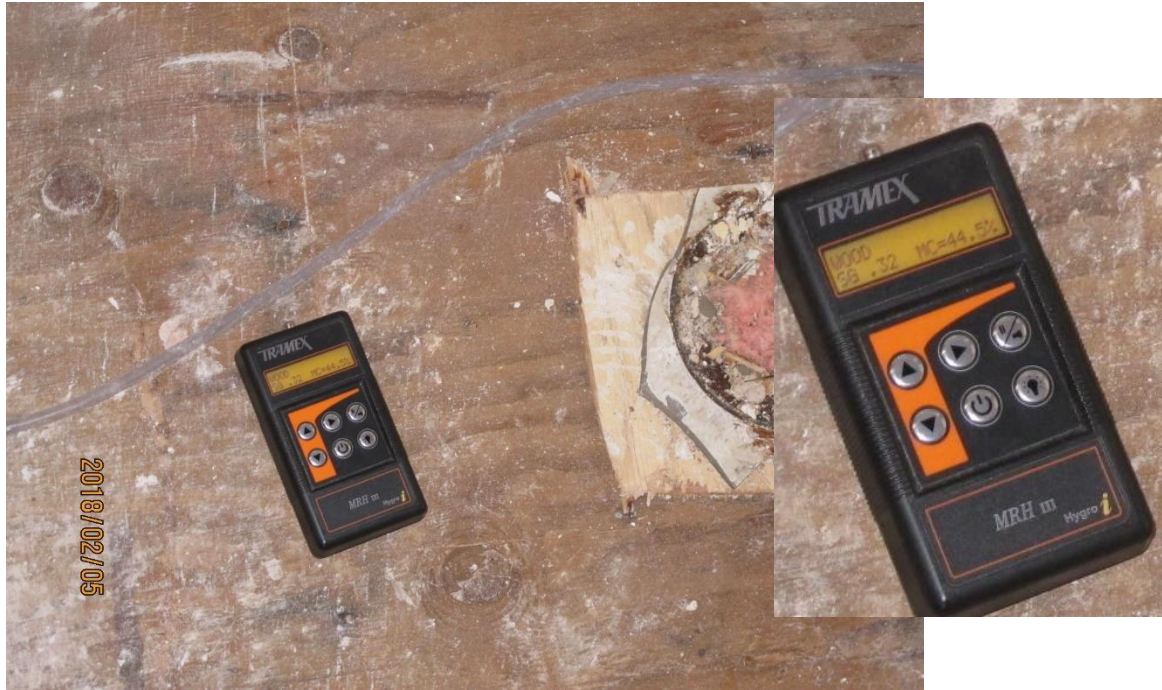
- The area had been gutted from floor to ceiling (see photos) with contents removed, some placed in the kitchen and garage (see photos).
- There was an Acme commercial dehumidifier operating to continue post-leak drying. [It was turned off during the air sampling activity.]
- The relative humidity was dry at 41% (59F).
- The moisture meter readings ranged from 17-45% MC with the highest readings in the half bath to the left side (see photo). [This elevated reading is unacceptable indicating that the subflooring needs extended drying or replacement.]

Unacceptable reading of 44% MC in utility room subfloor

MOISTURE: After a couple of weeks of drying, the subfloor in the bathroom where the leak occurred as well as the subfloor in the utility room below are well above NES’s guideline for acceptably dry conditions – 18% MC – two options exist:

- Continue operation of the dehumidifiers until the MM readings at several locations in the subflooring are below 18% MC.
- OR

- Remove and replace the damp subflooring.

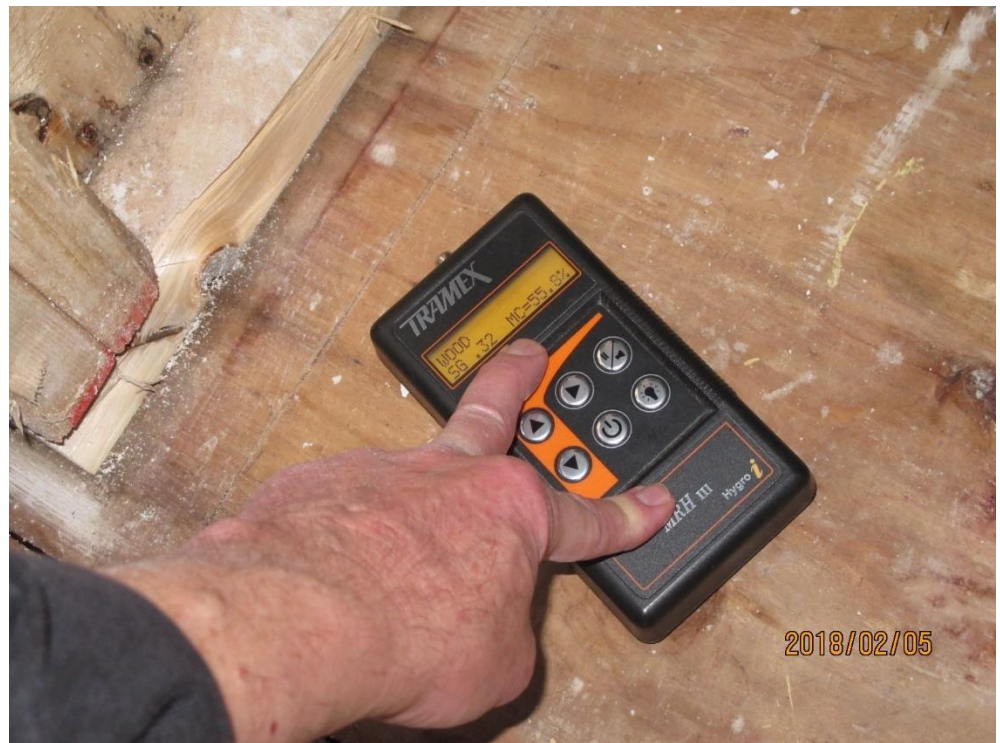
- The area had been gutted from floor to ceiling (see photos) with contents removed.
- There was an Acme commercial dehumidifier operating in the bathroom to continue post-leak drying. [It was turned off during the air sampling activity.]
- There were observations of fluffy debris on the floor, a possible indication of less than thorough “air polishing” during the initial round of remediation.
- The relative humidity was dry at 44% (58F).
- The moisture meter readings were:
 - Bathroom – 55% MC near the shower (see photo). [This elevated reading is unacceptable indicating that the subflooring needs extended drying or replacement.]
 - Bedroom – several locations across subfloor – 8-10% MC

Unacceptable reading
of 55% MC in
bathroom subfloor over
the garage
