Nauset Environmental Services, Inc.

27 April 2009

NES Job # 607B
Report No. NES/IAQ-09/

Re: Post-remediation Verification Inspection + Sampling
at 4 Fred's Way (Roberttown) with Scope of Work

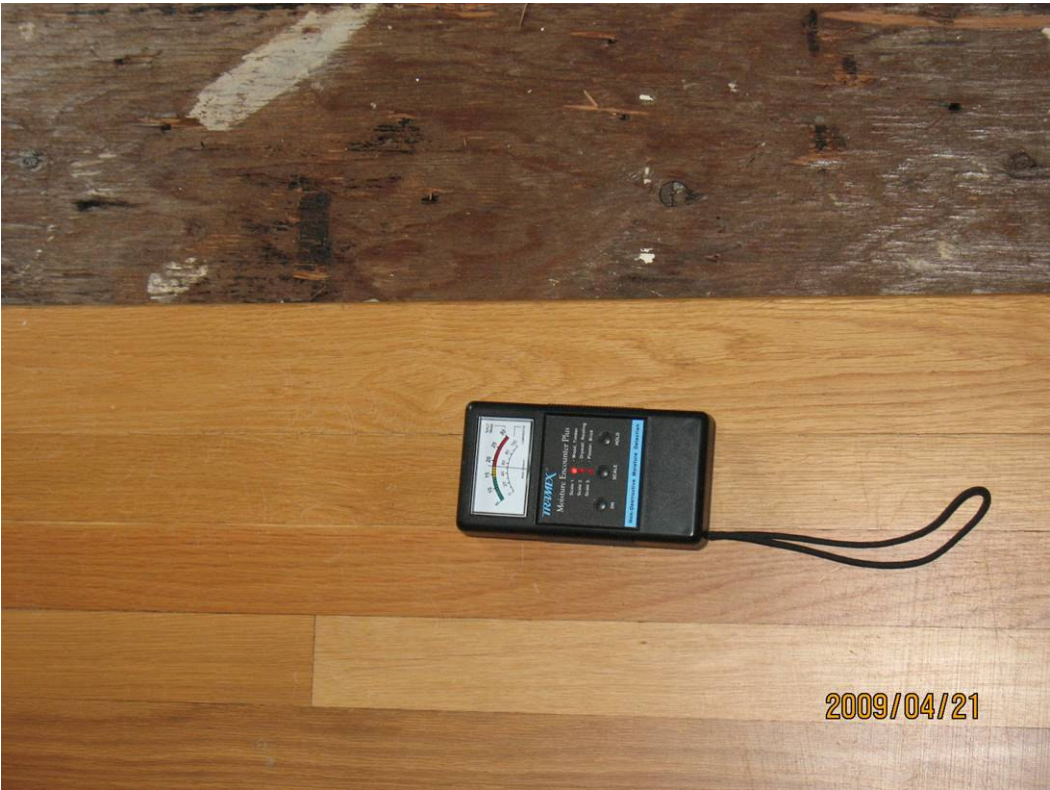
MM reading still marginal at 15+% MW near edge of kitchen step into dining room

- The MM no longer indicated slightly elevated moisture levels near the refrigerator or the central island cabinets (see photos). Near the step into the dining room the MM still registered marginally acceptable levels near 15% MW (see photo).

The basement was still damp at 60% RH, probably due to water still moving out of the concrete into the air, calling for on-going dehumidification as noted below. While the floor at the kitchen/dining room arch is still marginally damp, the other spots on the kitchen floor were now below 15% moisture in wood.

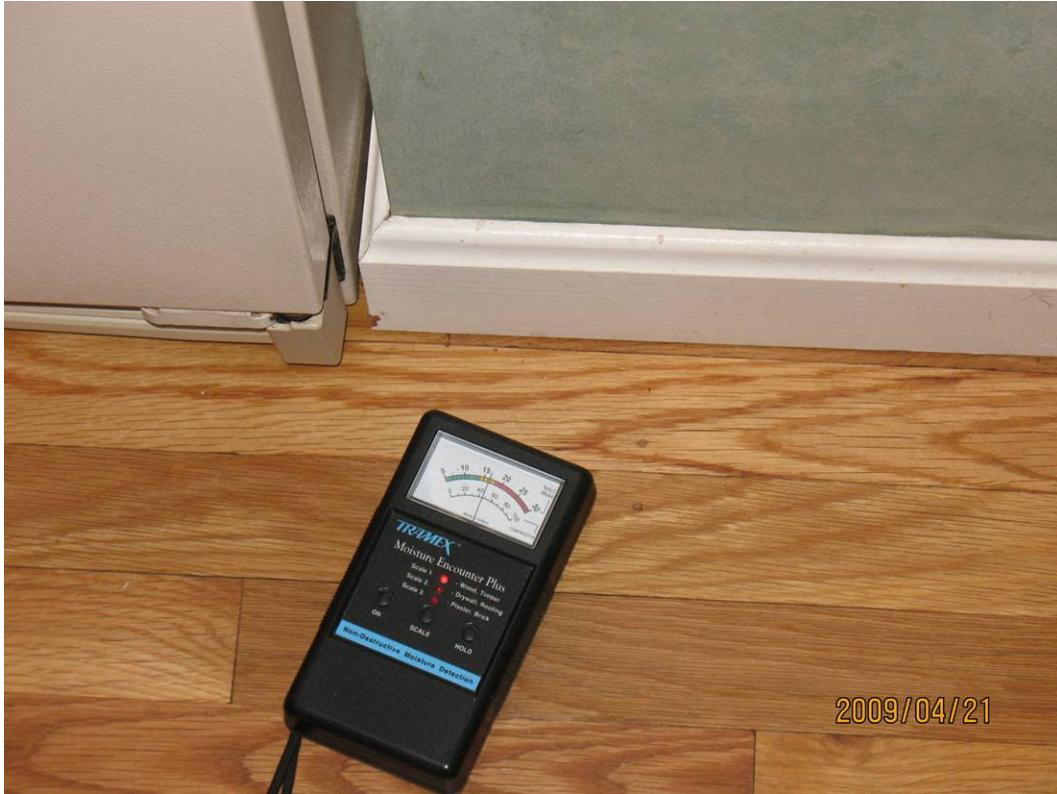
Satisfactory MM reading near the refrigerator

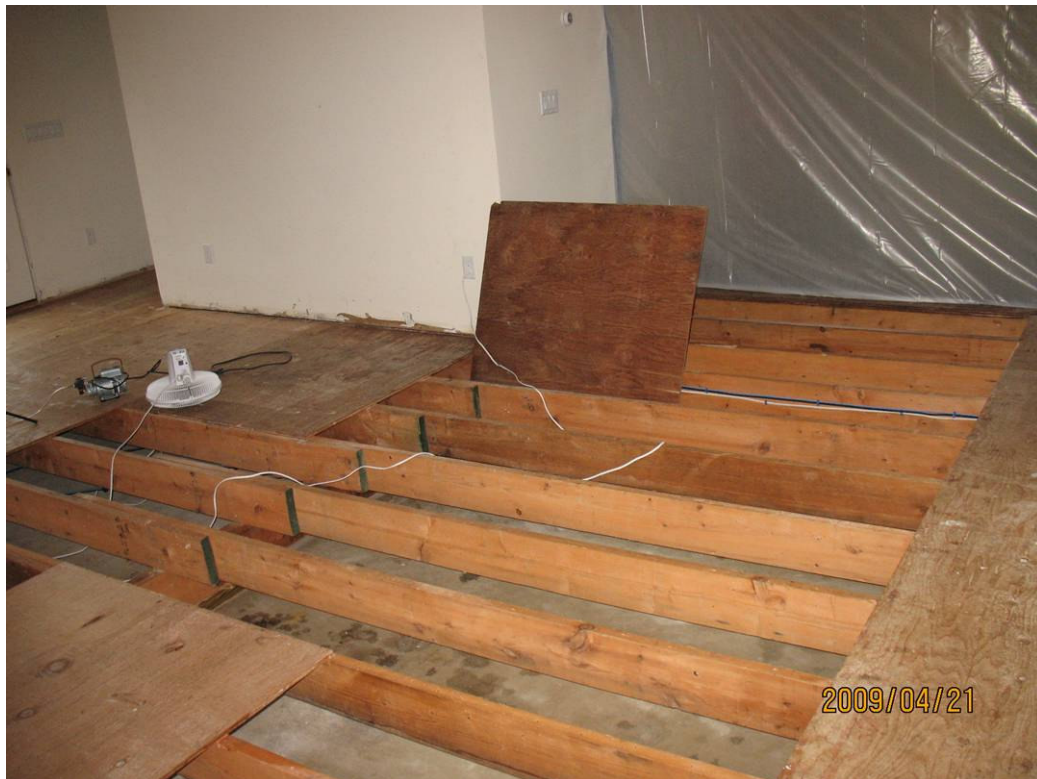
Expanded open floor area in living room.

- The dining room subfloor had been cleaned and sealed, as evidenced by its glossy finish. It appeared that additionally the subflooring had been removed from the living room (see photos) with the remaining surfaces cleaned and sealed.

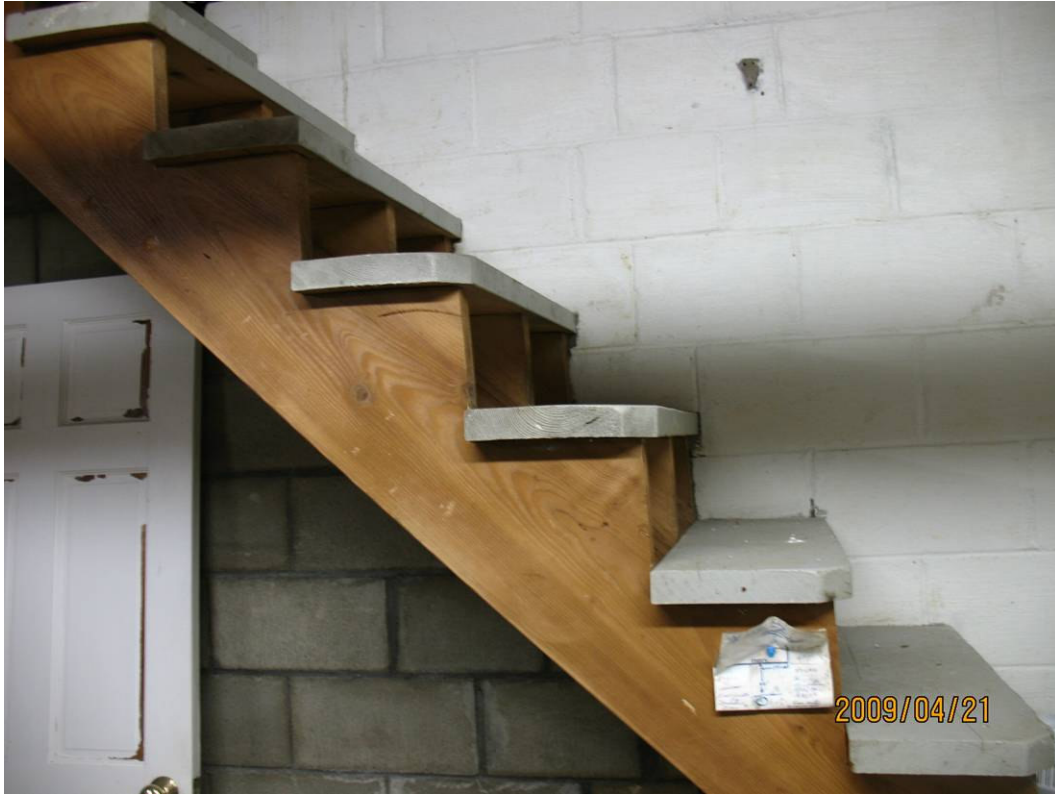
Absence of VMG on basement steps

- The basement contents were still out.
- There was no longer light visible mold growth (VMG) on some structural members. There was no longer any VMG along the drywall along the sides of the basement stairs and the underside of the stairs leading to the second floor (see photos).
- The central vacuum unit was still in place with its rust spots
- The air was damper than in March with a relative humidity at 60% at a temperature of 63F. This continued dampness is probably associated with moisture still coming out of the saturated concrete floor and calls for on-going dehumidification in the basement (see below).

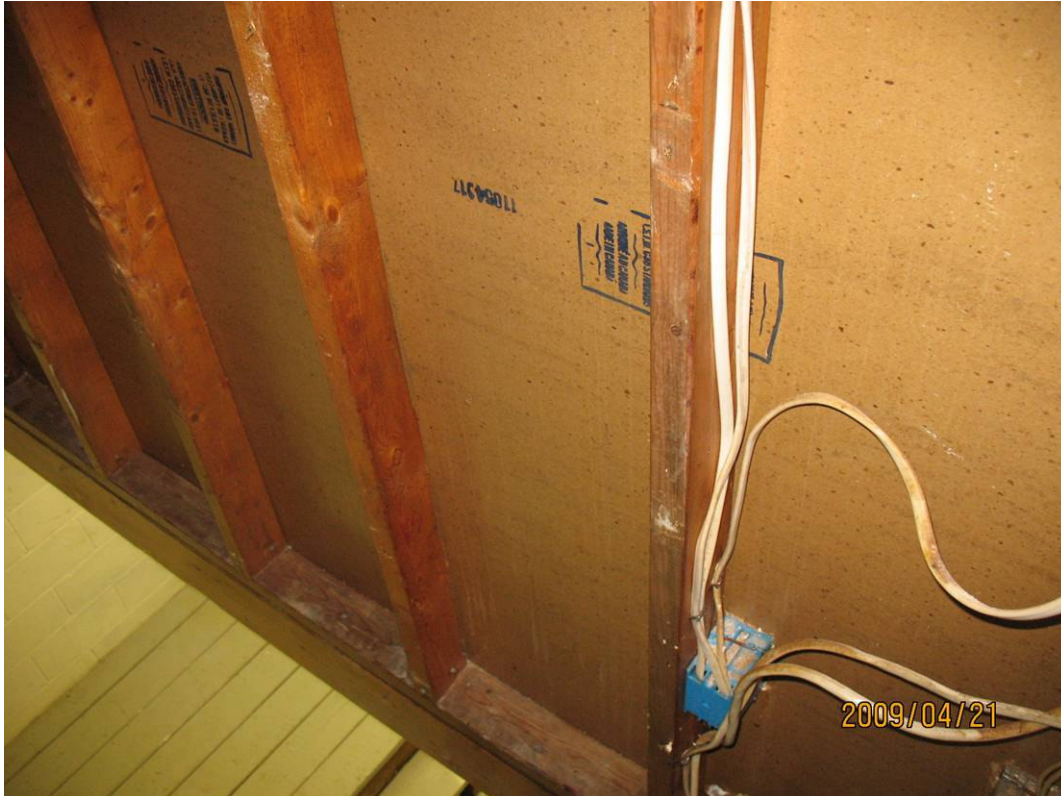
Absence of VMG on drywall going down basement steps
