Nauset Environmental Services, Inc.

Report No. NES/IAQ-14/1597

Re: Mold/moisture inspection for knee wall attic
for 32 Riverside Drive (Taunton)

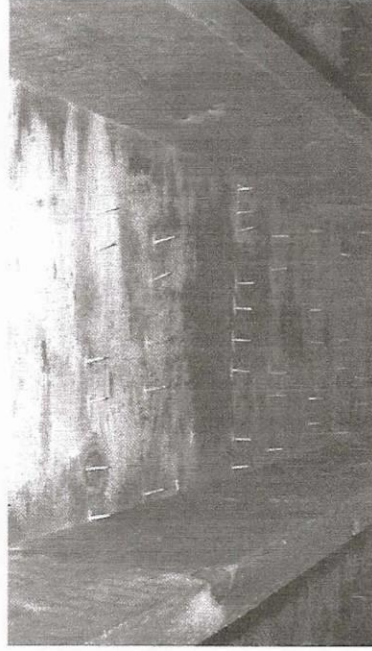
Black mildew on attic sheathing. The nails (protruding through the sheathing between the two rafters) are what hold the roof shingles onto the sheathing. This north-facing slope of a gable roof is covered with black microfungi (not *Stachybotrys* mold). The black growth gets denser toward the overhang (at the bottom of the picture) where it is colder. The white ovals at the nail penetrations indicate a lack of mold growth; the zinc that leaches from the galvanized nails into the wood is toxic to mold.

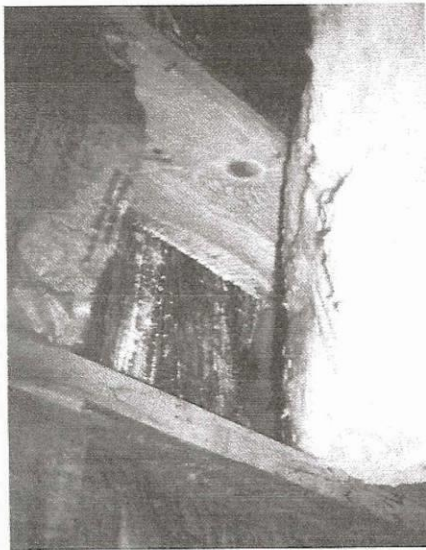
Rotted sheathing in a flat roof. The dark plywood sheathing between the lighter-colored rafters has been damaged by wood-decaying fungi. Water poured out of the fiberglass as the insulation was lowered, and the white semicircular threadlike pattern above the knot in the rafter is probably the mycelia of macrofungi that were starting to destroy the wood structure because of the saturated conditions.
